# Memorandum

**RE:** Village of Skaneateles new sidewalk prioritization assessment document

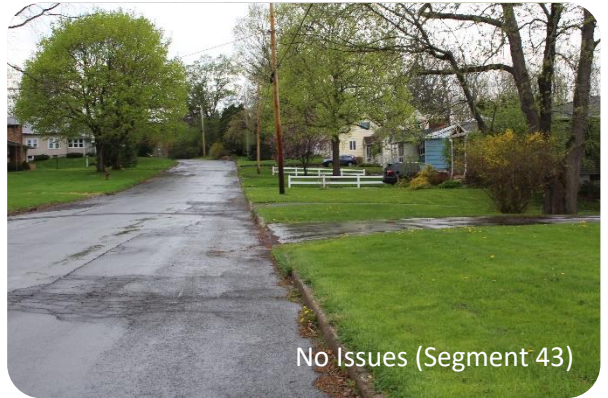
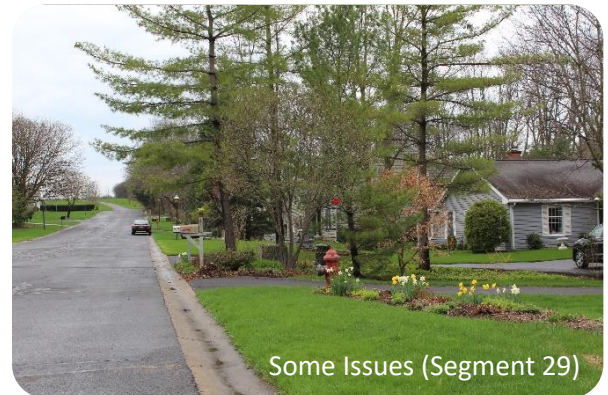
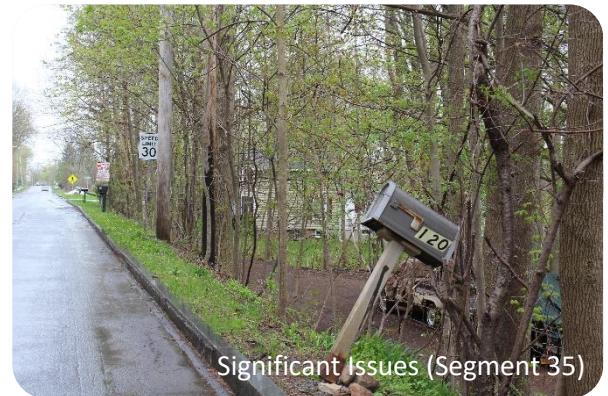
Trees and significant residential landscaping are a potential obstacle for the addition of a sidewalk to a street. During this inventory, large trees and bushes that would hinder the construction of sidewalks were observed in a few segments. It would be expensive to remove some large caliber trees and root systems for the sidewalk and, therefore, these segments ranked as having “significant issues” due to the amount of work/cost that it would take to clear them. Both tree size and quantity were taken into account when assigning a rating.

*Examples of ratings based on trees/landscaping.*

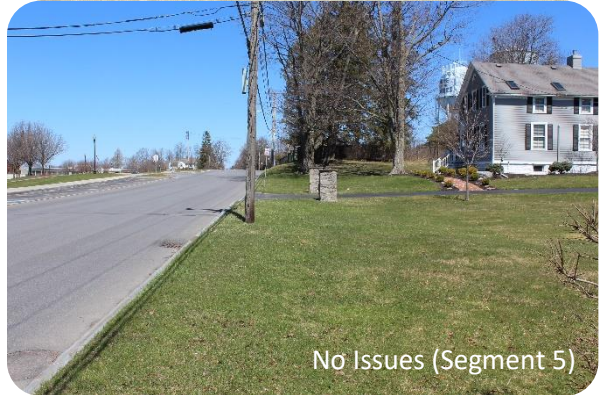
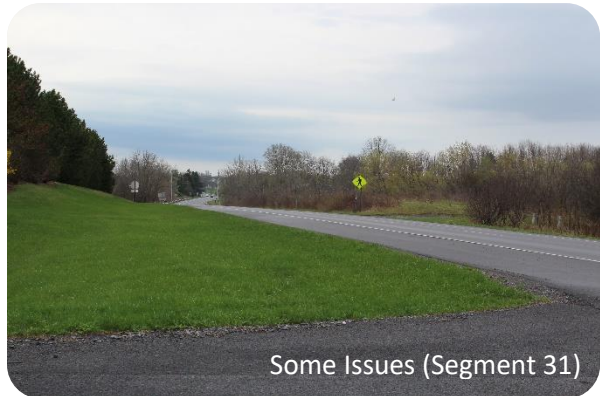
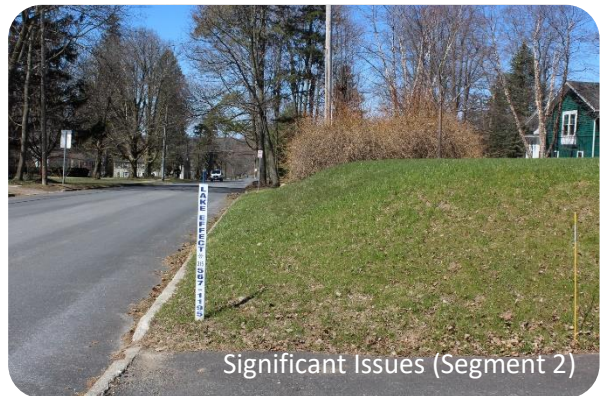
Staff observed the grade of the area adjacent to the road during the field inventory. The assessment did not consider the running (linear) slope of the road, but rather the cross-slope (or side slope, perpendicular to the road) of the land immediately adjacent to the road. A steep side slope could require a significant amount of cut and/or fill to achieve the necessary cross-slope of the sidewalk, and could potentially necessitate a retaining wall in some locations. This sort of earthwork would add significantly to the cost of a new sidewalk. Where roadside topography was observed to be an issue, the slope typically rose away from the road.

*Examples of ratings based on roadside topography.*

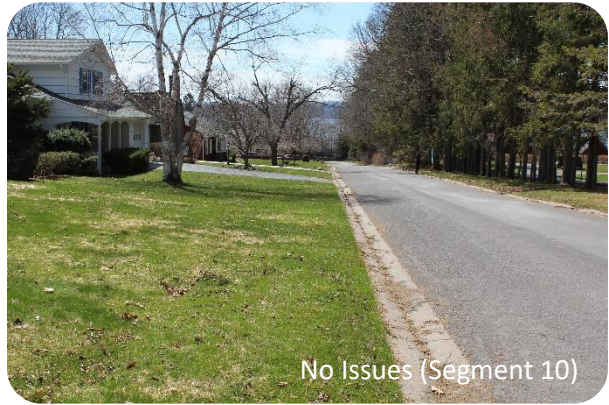
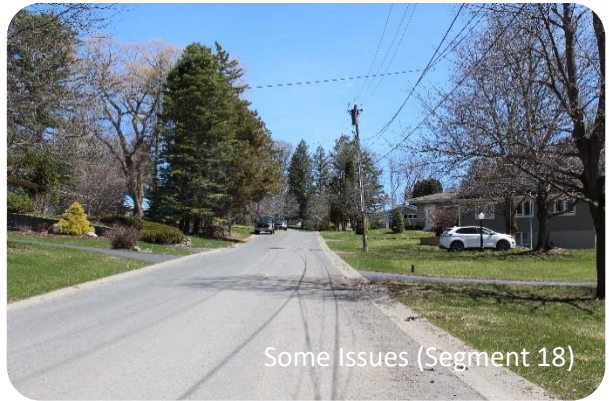
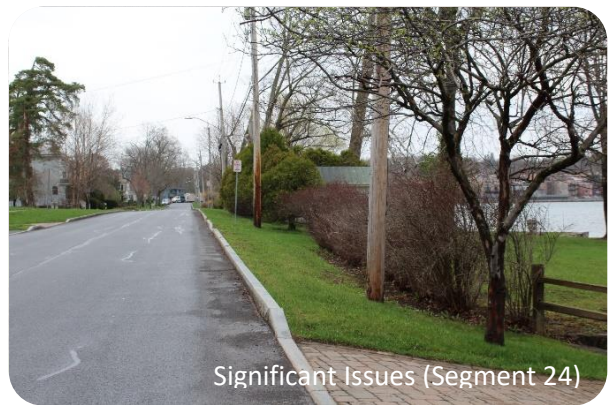
Utility poles usually exist within the right-of-way of roads and are a potential obstacle when building new sidewalks. They are very difficult, and potentially expensive, to move. Sidewalks could be located around the poles if adequate space is available. The village would also have to coordinate with the utility company that owns the poles and lines.

*Examples of ratings based on utility poles.*

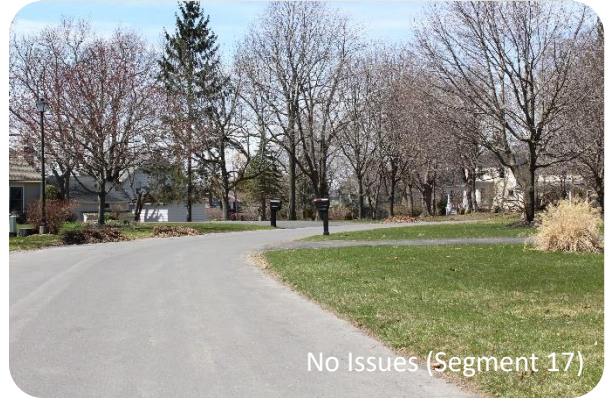
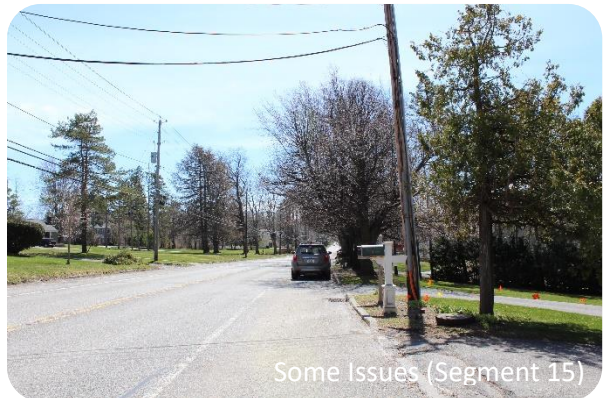
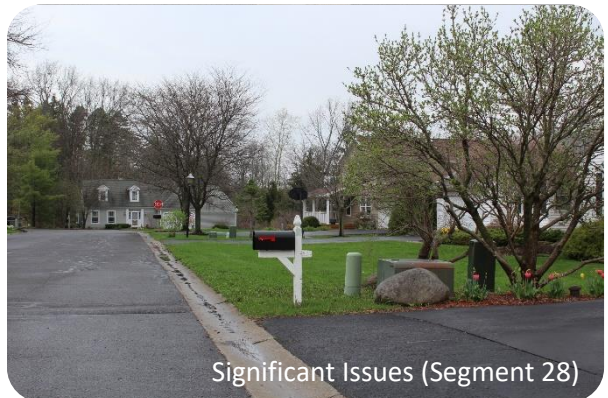
Electric boxes, streetlights, fences, and houses/garages present obstacles to sidewalk construction. Removing or relocating these could add significantly to the cost of a sidewalk installation, and would require coordination with private property owners.

*Examples of ratings based on buildings or other structures.*

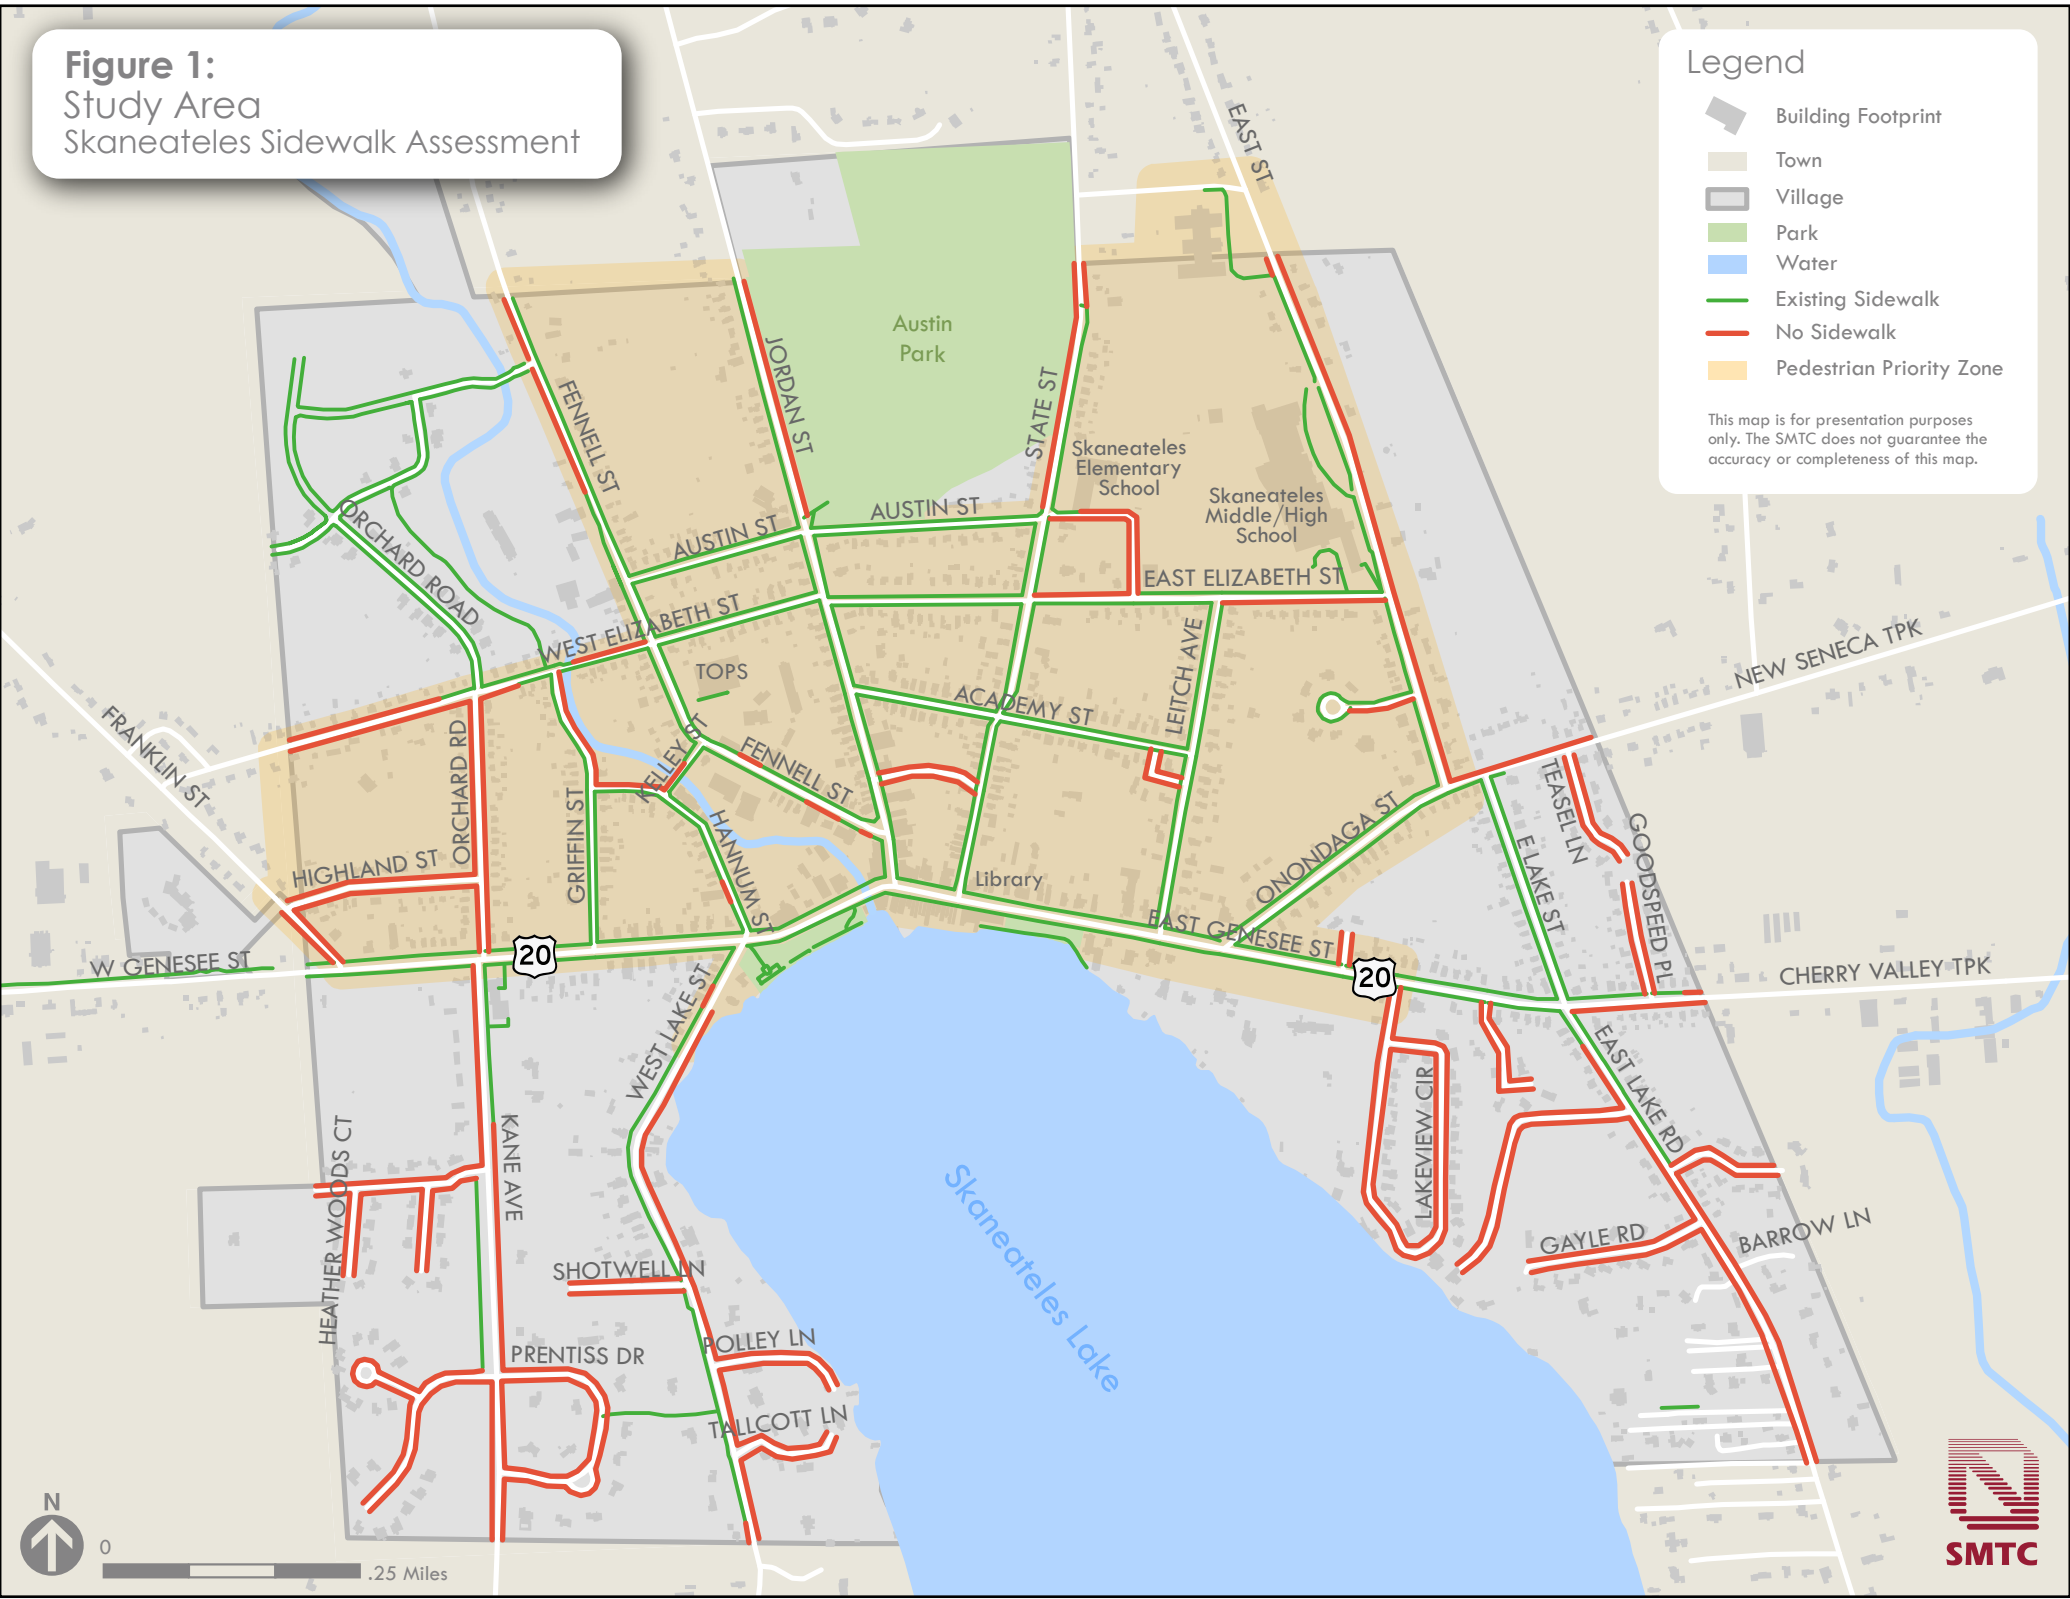
**Figure 1:**  
Study Area  
Skaneateles Sidewalk Assessment

The Village of Skaneateles has a good amount of existing sidewalk infrastructure. The major pedestrian routes within the village along Route 20, Fennell Street, Jordan Street, and State Street all have adequate pedestrian infrastructure (see Figure 1 – Study Area). There are 15.6 miles of existing sidewalk, which covers about half of the village, most being in the core.

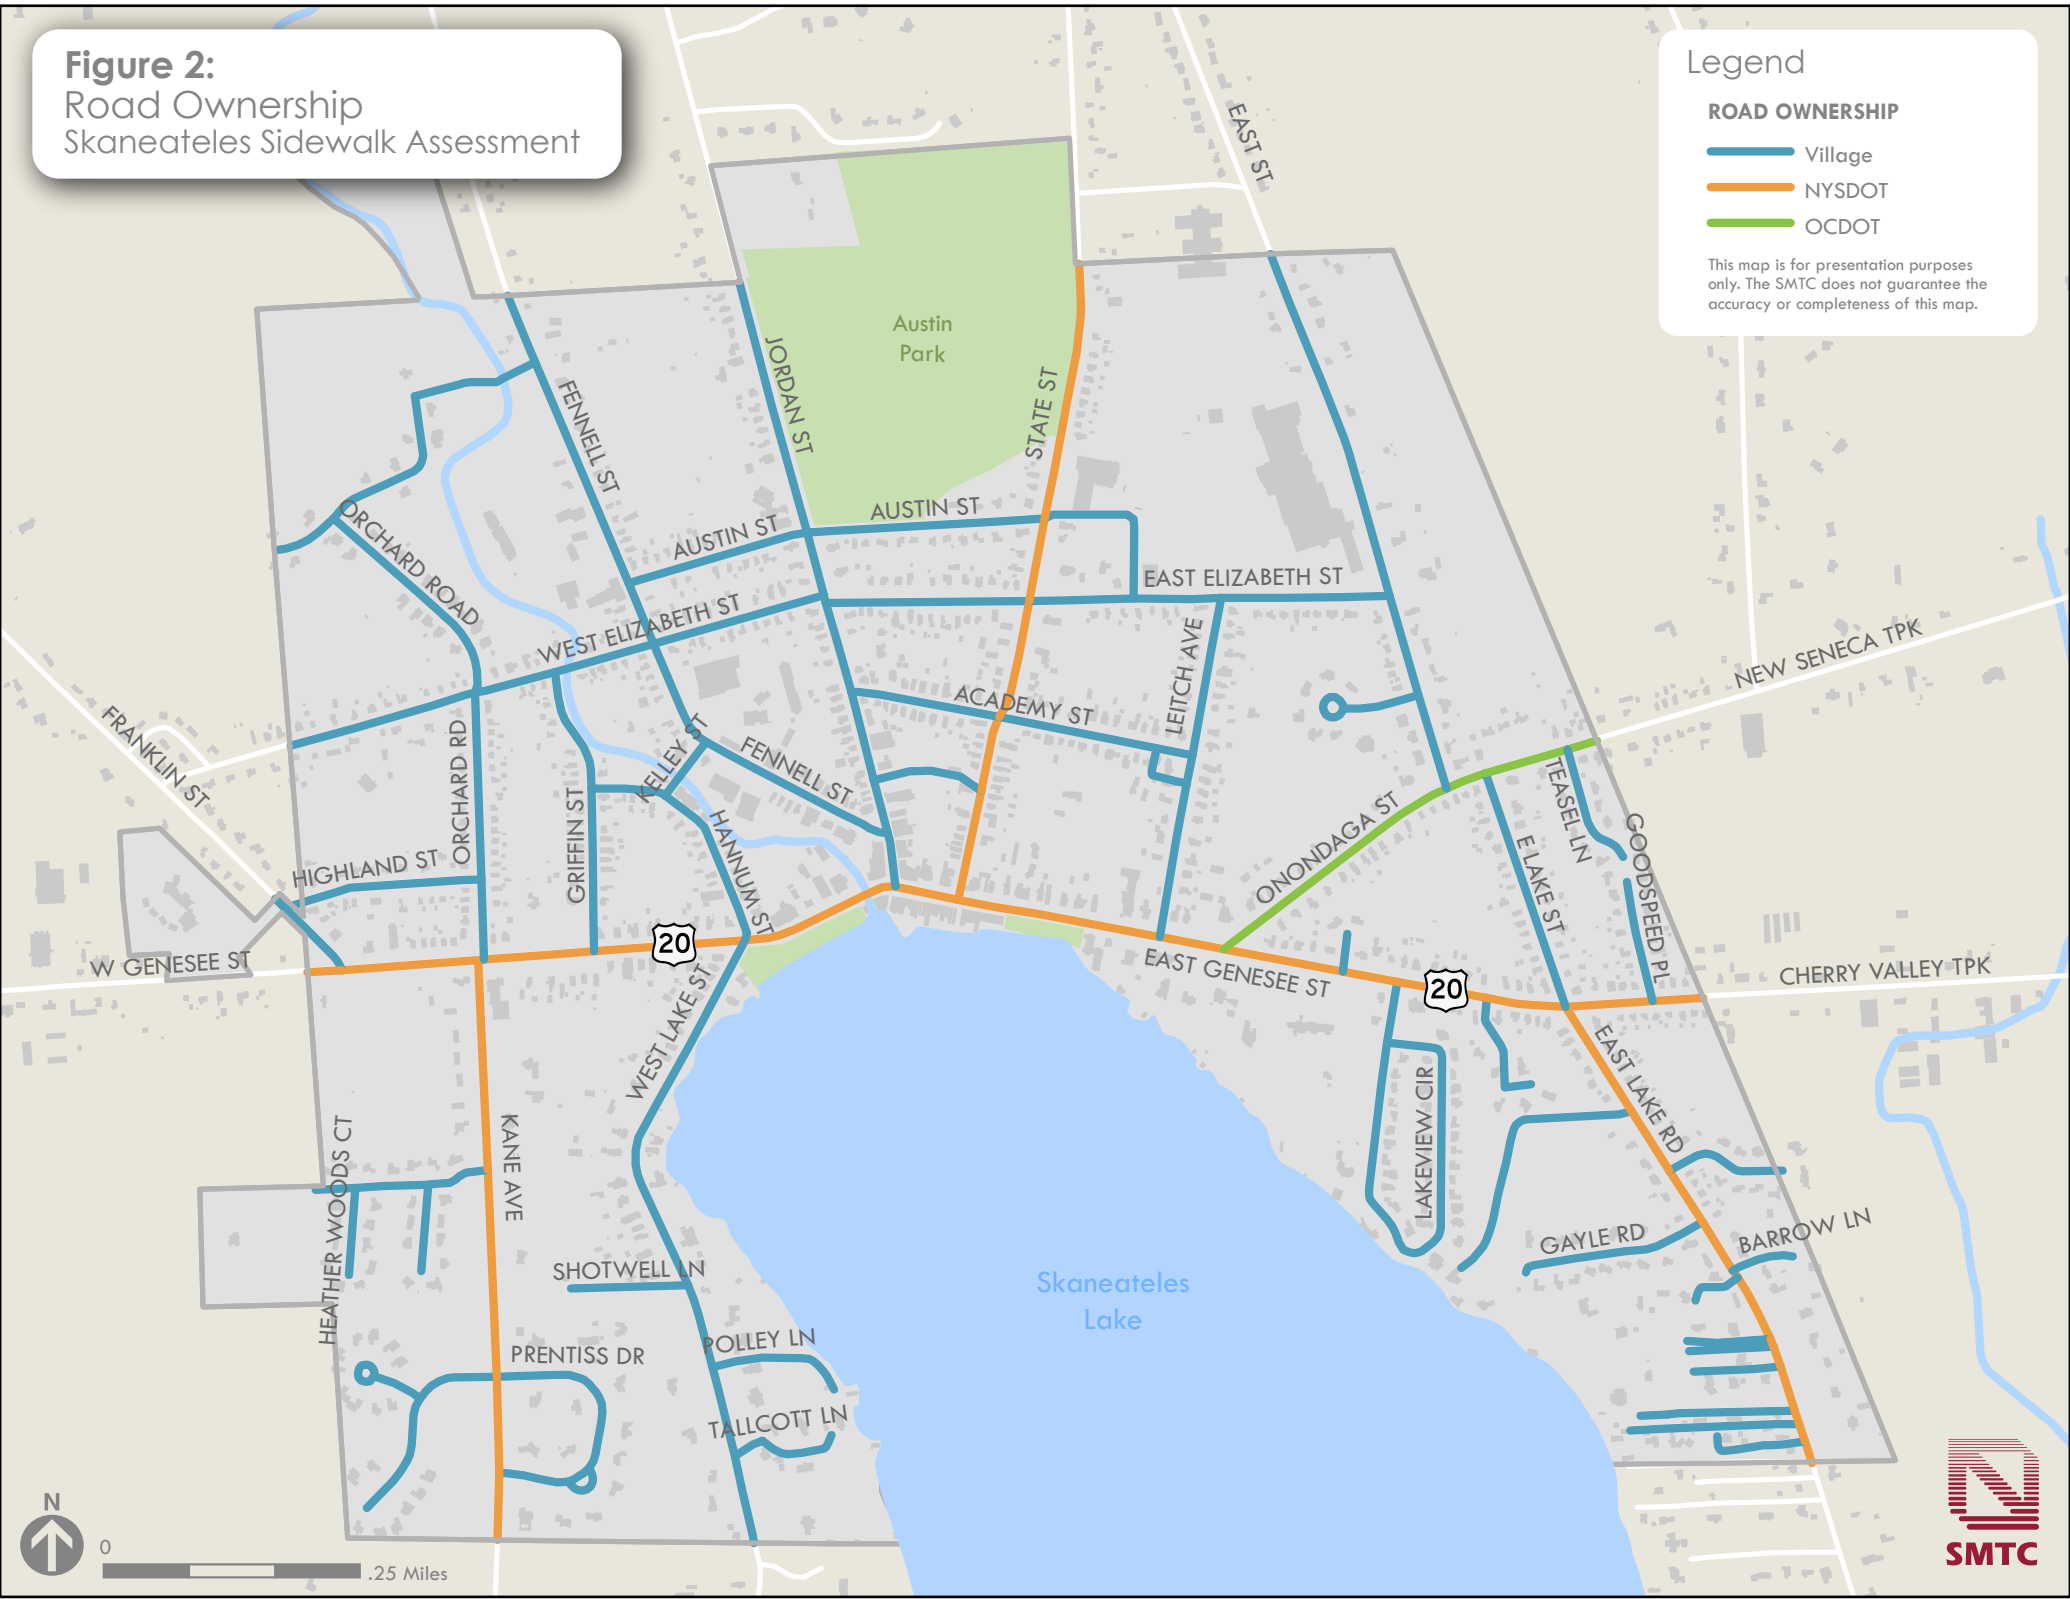
**Figure 2:**  
Road Ownership  
Skaneateles Sidewalk Assessment

Figure 2 shows Road Ownership by entity. East Lake Street (State Route 41) and Kane Avenue (State Route 41A) are State-owned facilities. Onondaga Street (County Road 41) has dual ownership: the County owns and maintains the asphalt, while the village owns and maintains everything else within the right-of-way. The remaining roads within the village are village-owned roads.

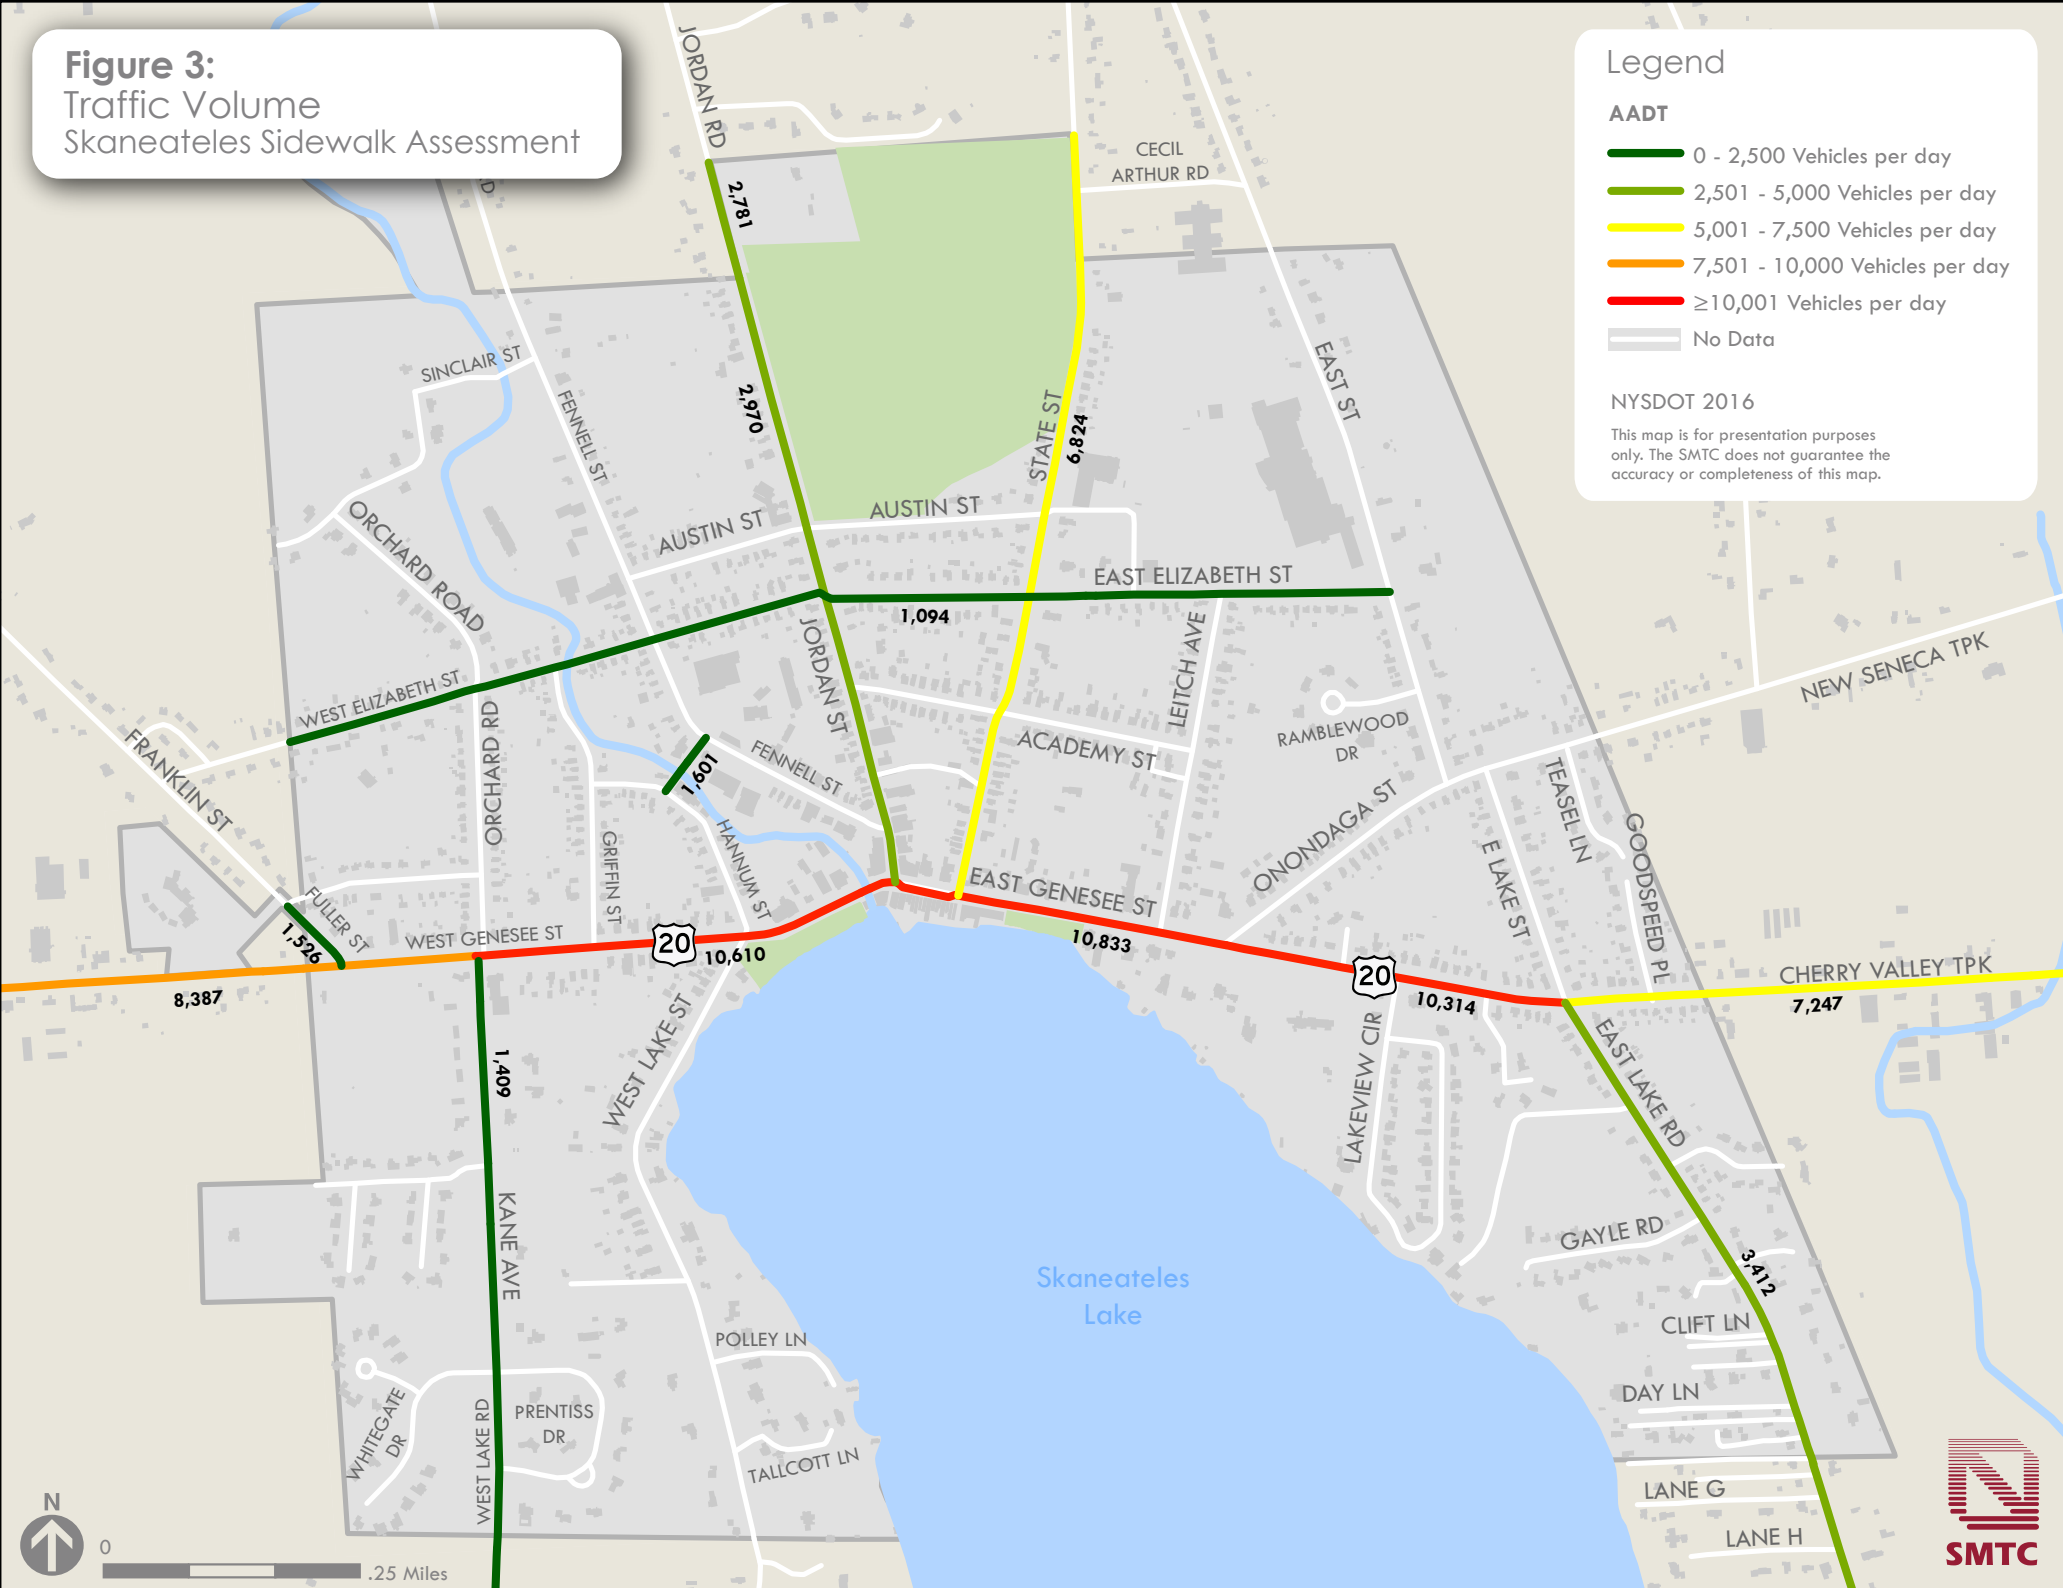
**Figure 3:**  
Traffic Volume  
Skaneateles Sidewalk Assessment

The Average Annual Daily Traffic (AADT) is the total volume of vehicle traffic on a road segment for a year divided by 365 days. Figure 3 shows the total estimated AADT by road segment in the Village. The Route 20 corridor through the village has the highest volume of traffic, with about 10,000-11,000 vehicles per day. State Street carries a moderate volume of daily traffic, with about 6,800 vehicles per day. Jordan Street and East Lake Road each carry about 3,000 vehicles per day. Kane Avenue, and West/East Elizabeth Street have even lower volumes, with about 1,100-1,400 vehicles per day. No traffic volume data are available for the remainder of the local roads within the village (though these likely have even lower volumes). All available data was provided by New York State Department of Transportation for the 2016 year.

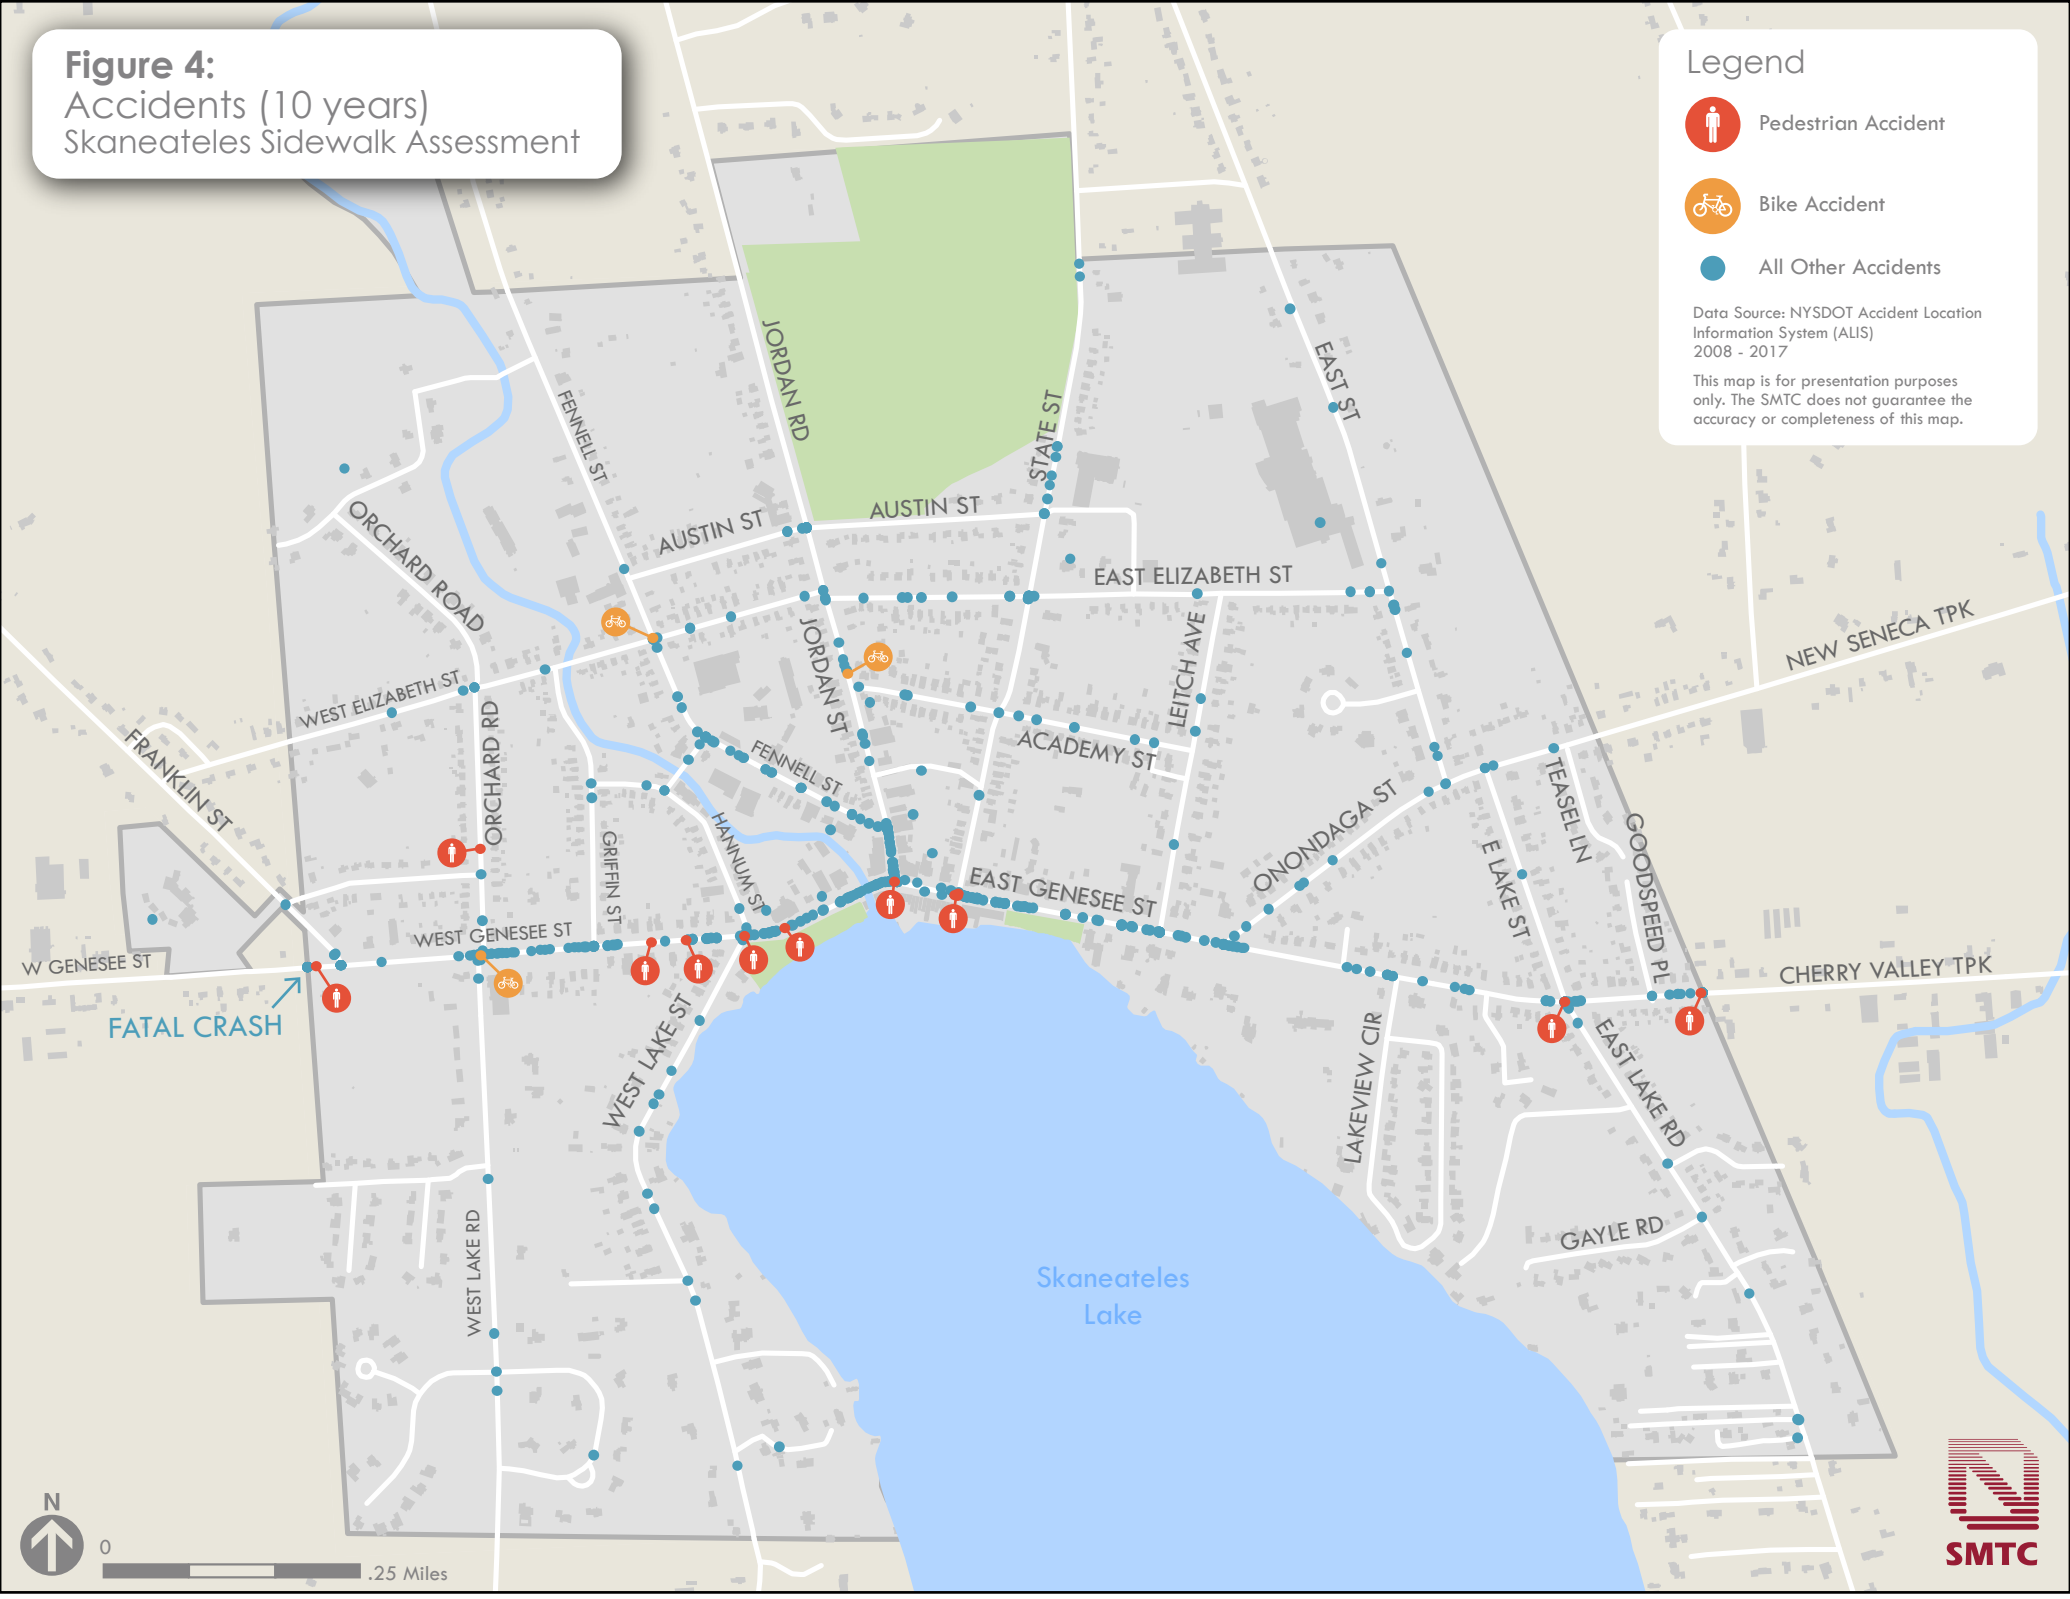
**Figure 4:**  
Accidents (10 years)  
Skaneateles Sidewalk Assessment

The SMTC examined data from the NYSDOT's Accident Location Identification System (ALIS) database for all roads available within the Village of Skaneateles for the most recent ten-year period (2008-2017). Accidents are shown for study area roads only, over the past ten years, on Figure 4. There were 681 total collisions, 564 of them between two or more vehicles. There were 13 pedestrian accidents and three bicycle accidents with motor vehicles. Table 1 shows the number of collisions by type and severity.

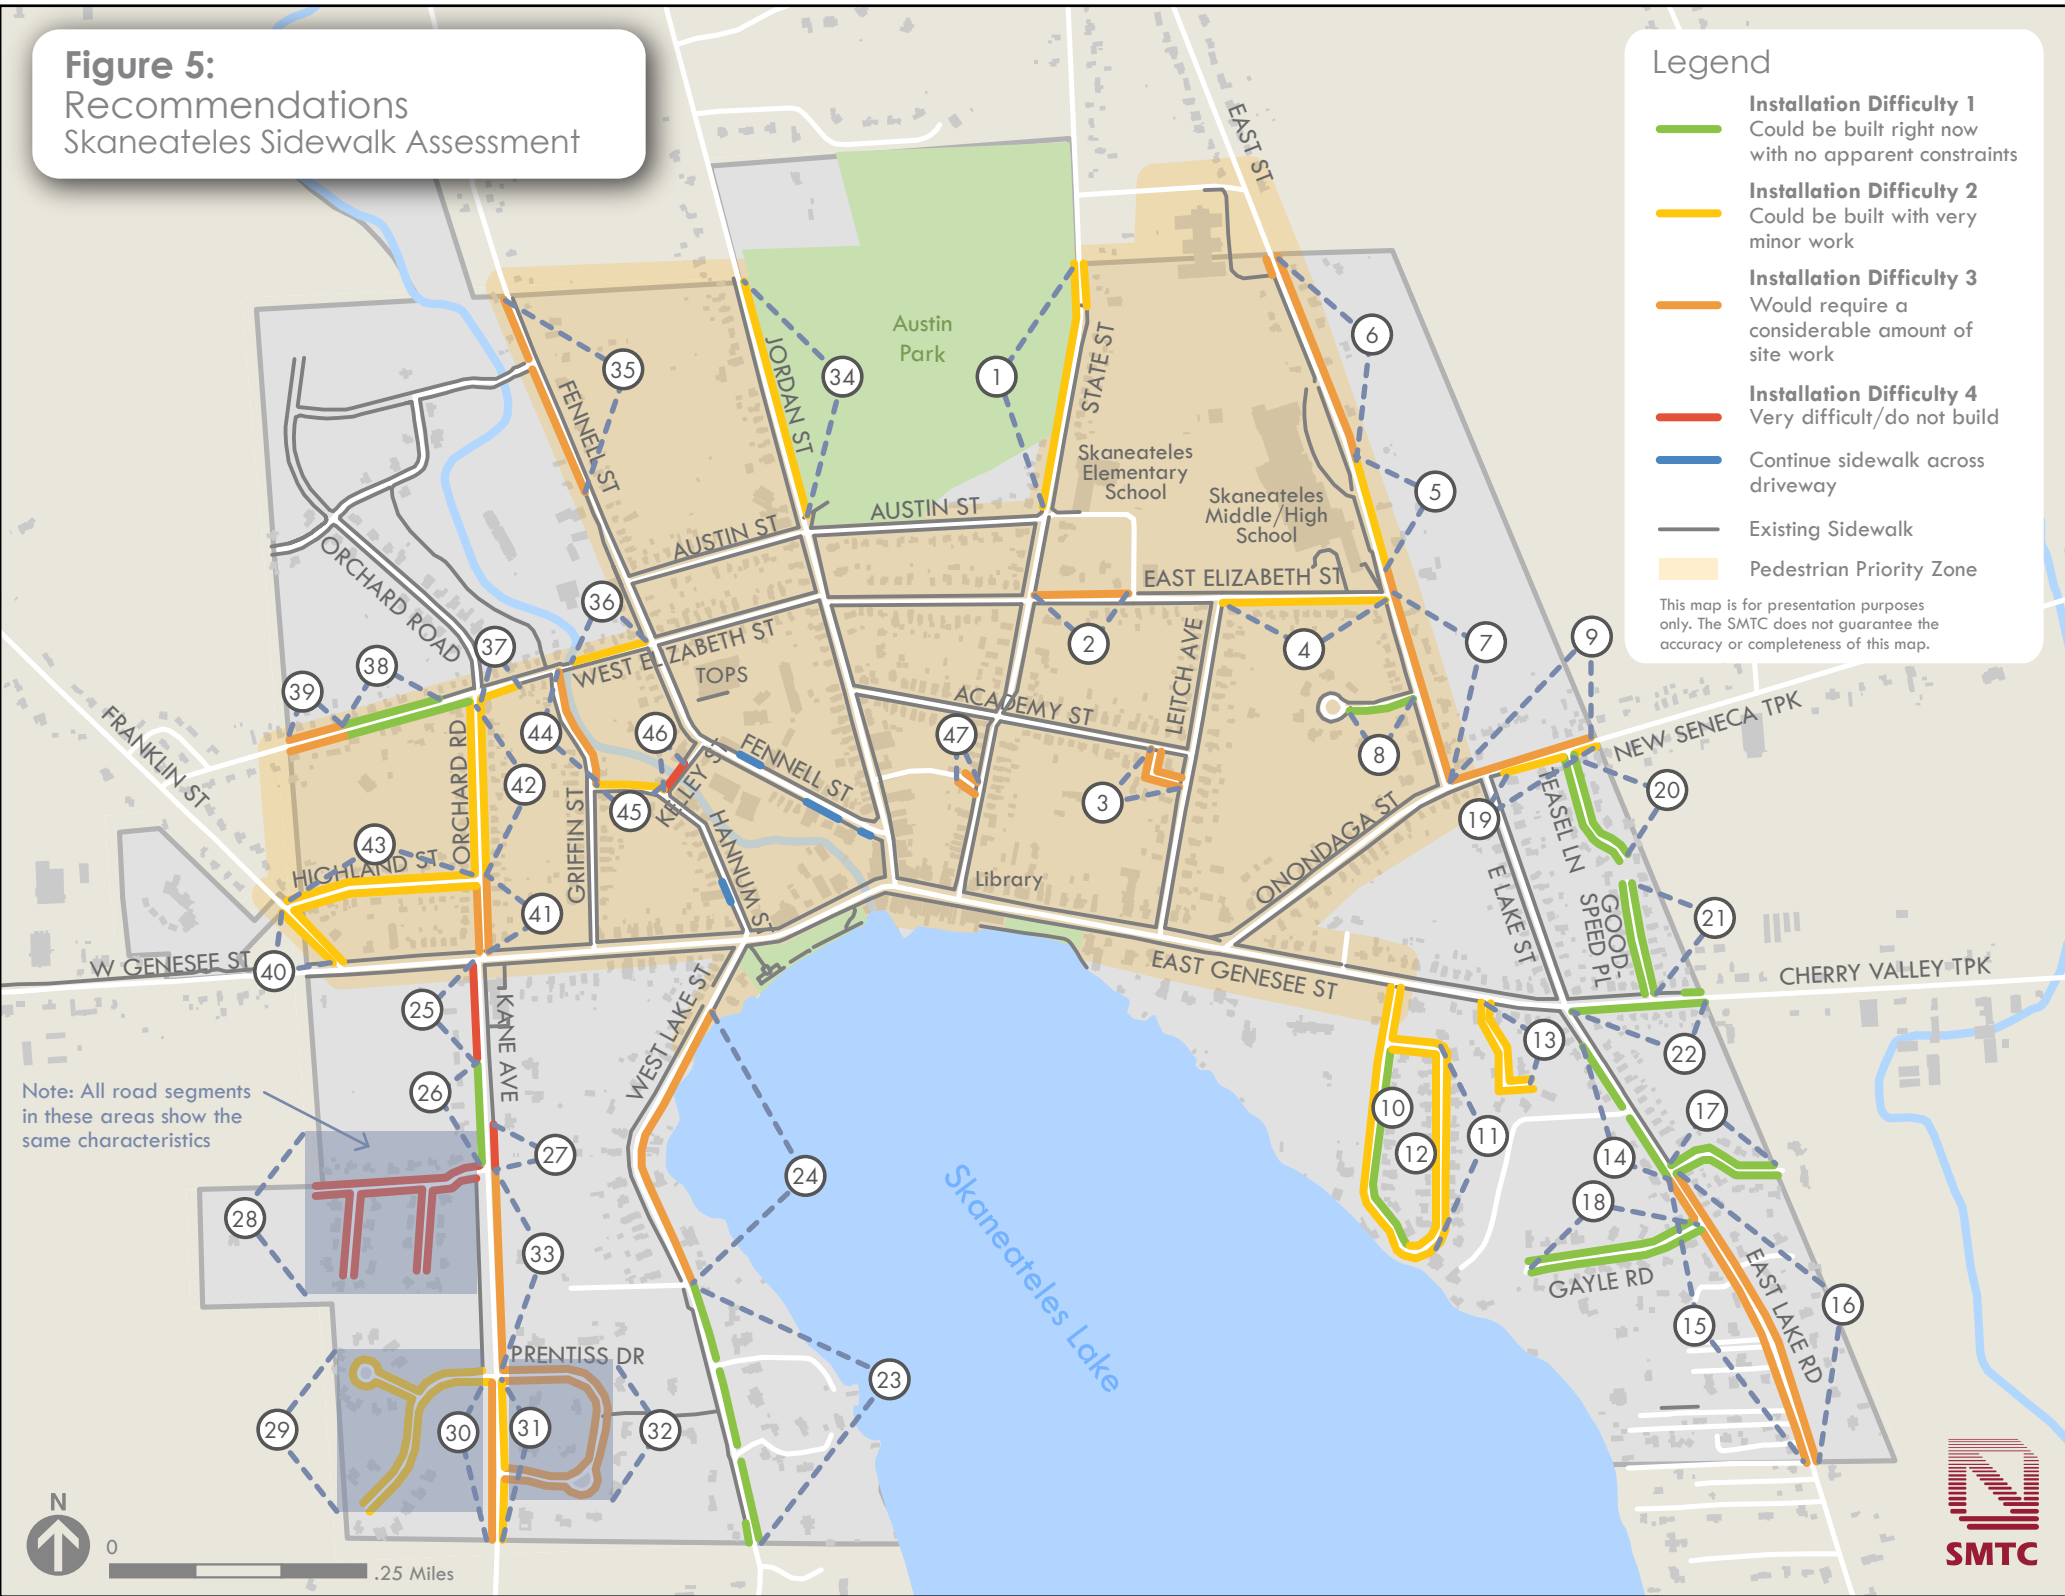
**Figure 5:**  
Recommendations  
Skaneateles Sidewalk Assessment

Figure 5 shows the locations of the study area segments by installation difficulty category.

SMTC staff also noted a few locations on Fennell Street and Hannum Street where there are gaps in the existing sidewalk at large commercial driveways. Ideally, the sidewalk should be continuous through the driveway. These locations were not rated, nor were they assigned a installation difficulty category. These locations are also shown on Figure 5.

Note: All road segments in these areas show the same characteristics

- *Complete sidewalk infrastructure within the pedestrian priority zone.* SMTC's Pedestrian Priority Zones identify areas that are most likely to have a high demand for pedestrian facilities. As shown on Figure 5, most of the roads within the Village of Skaneateles' Pedestrian Priority Zone already have sidewalks. One approach the village could take is to focus on completing the sidewalk network within this zone. Specifically, segments that were determined "Installation difficulty 1" (could be built right now with no apparent constraints) within the priority zone would be a logical first step. However, there are only two Installation difficulty 1 segments within the pedestrian zone (segments 8 and 38). There are a number of Installation difficulty 2 segments within this zone, though. With this approach, some of the Installation difficulty 1 locations might be bypassed in favor of some Installation difficulty 2 locations that are within the Pedestrian Priority Zone.
