City of Syracuse Safety Assessment (2021)

Syracuse Metropolitan Transportation Council

Final Report

June 23, 2021

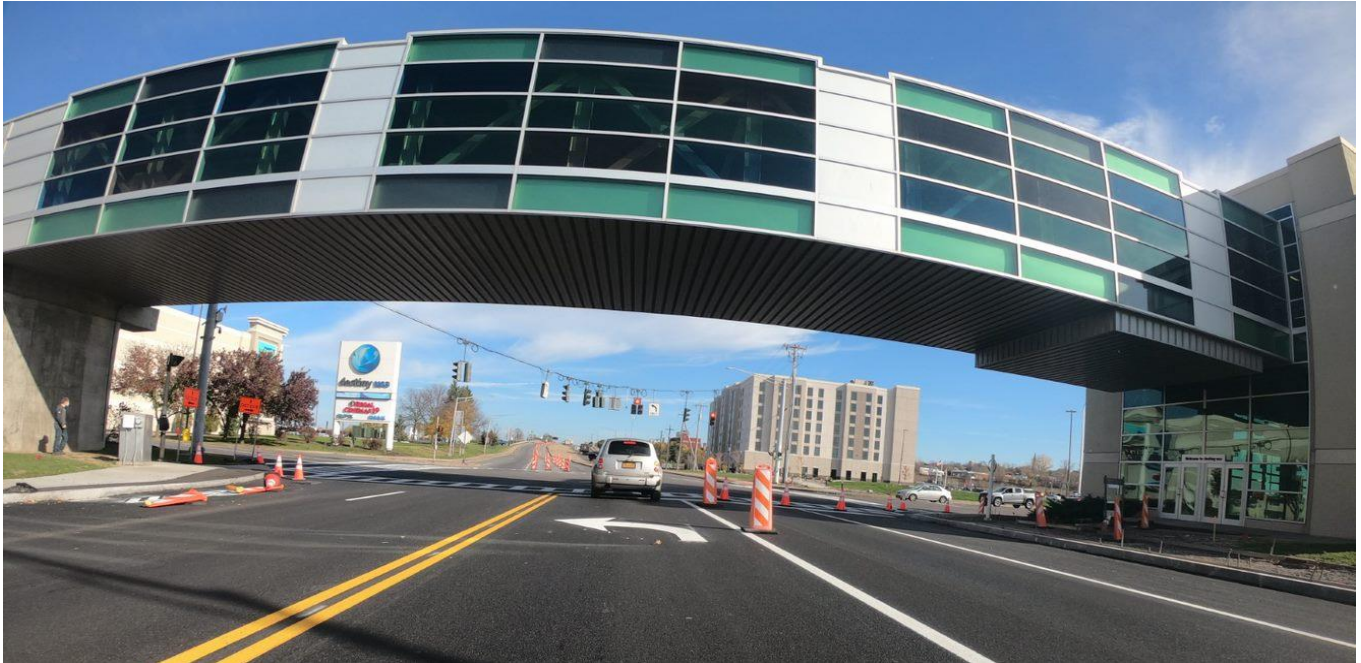
Image 1 – Hiawatha Boulevard West looking towards the Solar Street Intersection – repaving, restriping, and pedestrian facilities under construction. Embassy Suites is the hotel shown in the distance on the right side of the image. An enclosed pedestrian bridge connects the Solar Street lots to Destiny USA. The bridge spans above Hiawatha Boulevard and Harborside Drive. The bridge casts a shadow on the road and crosswalk beneath. Lighting does not exist on the bottom of the bridge. The bridge's Hiawatha Boulevard entrance (shown) did not appear to be ADA accessible (with door push buttons). Pedestrian facilities at the intersection were under construction at the time of the site visit. Sidewalks do not exist between the mall's entrance (approximately 130 feet away) and this intersection. Furthermore, the mall's entrance is not at grade level and must be accessed by traveling approximately 170 feet along Harborside Drive (no sidewalks) to a crosswalk that provides access to a ramp on the opposite side Harborside Drive. The ramp extends approximately 190 feet to the mall's entrance.

During the site visits, staff noted road construction at a few ‘hot spots,’ which made it difficult to confirm road attributes at those locations. For example, Image 1 shows road construction at the Hiawatha Boulevard West / Solar Street intersection. Descriptions are based on observations that existed at the time of the visit. Furthermore, observed conditions may not have existed during the 5-

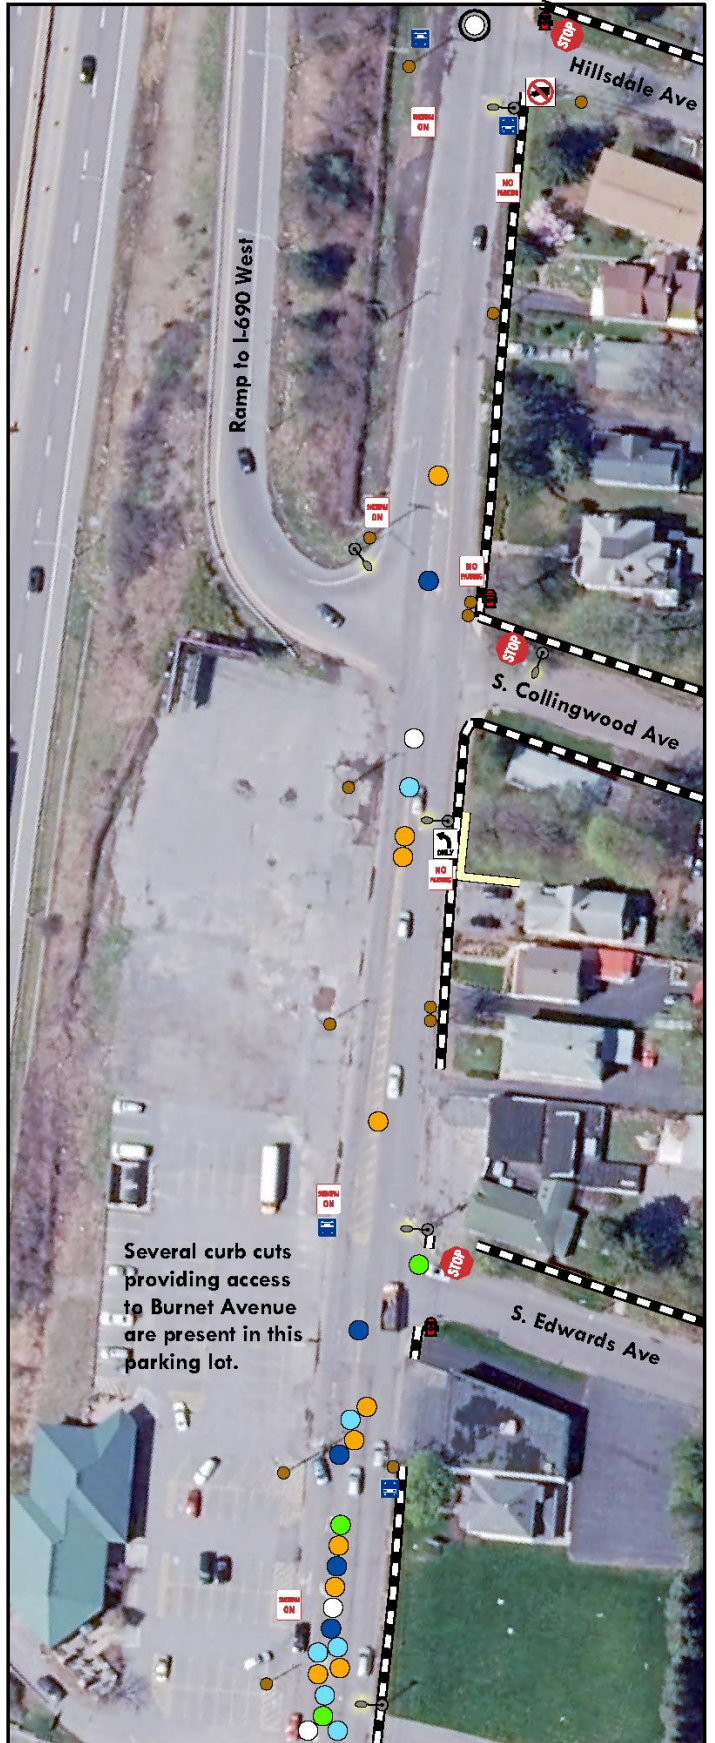
Several curb cuts providing access to Burnet Avenue are present in this parking lot.

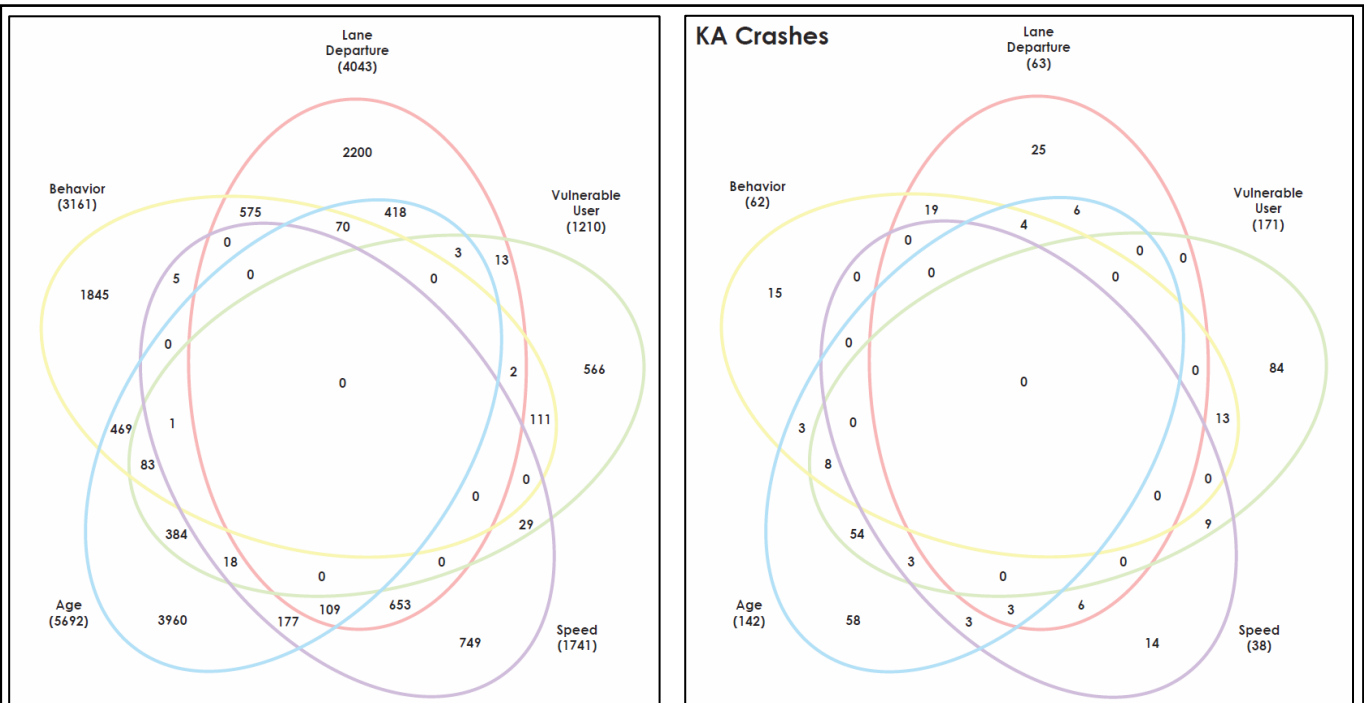
Figure 22 - Crashes by Emphasis Area Category

As mentioned, a crash may fit into one or more than one emphasis area category. For example, a speed-related crash may also involve a lane departure and thus be assigned to both categories. The following two Venn Diagrams¹⁷ show the number of crashes for each emphasis area and the number of crashes that can be assigned to one or more emphasis areas. Figure 22 shows two diagrams. The first diagram sorts all emphasis area crashes - regardless of severity - into one or more Emphasis Area categories based on assigned crash type(s). The second diagram sorts fatal and serious injury (KA) crashes by emphasis area. The figure summarizes findings in table format for comparison purposes.
