Safety Improvement Analysis

City of Syracuse

Syracuse Metropolitan Transportation Council

February 2013

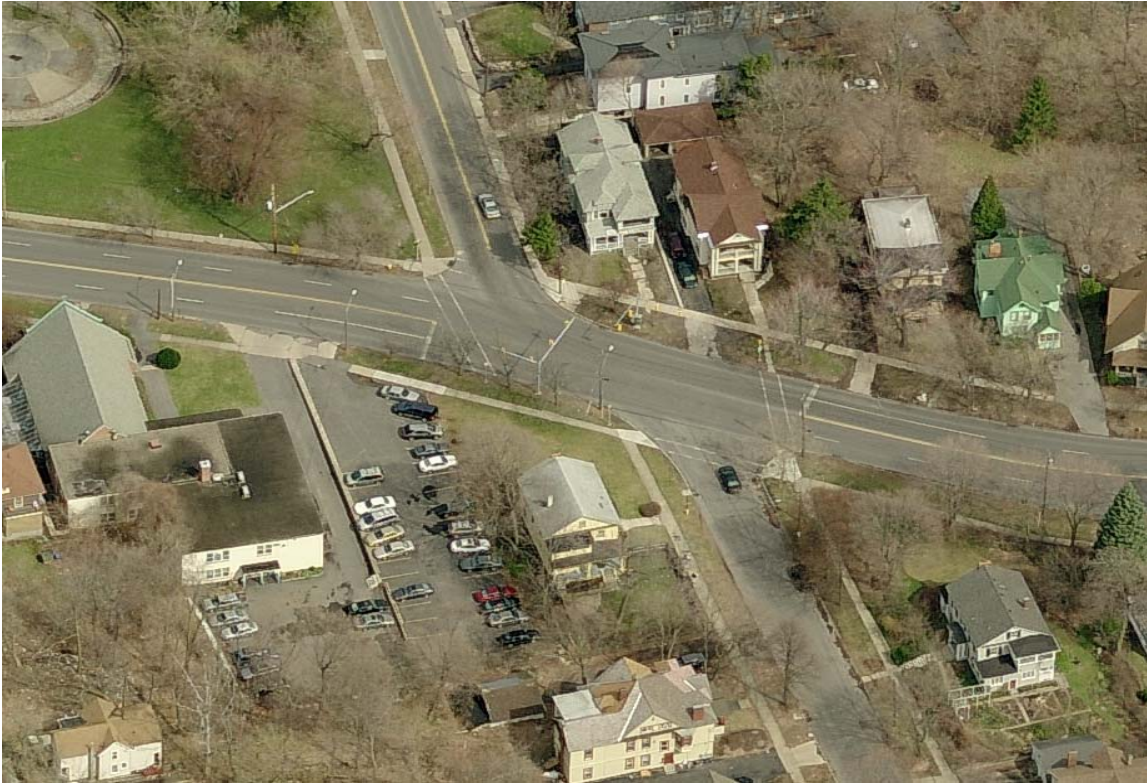
Aerial photo of East Genesee Street – Columbus Avenue intersection (looking north)

The immediate surrounding land use is residential, mainly to the east of the intersection. On the southwest corner there is a sizable religious institution, and on the northwest corner there is a city park. The estimated average daily entering vehicles (ADEV) at this intersection is 12,500 vehicles per day.

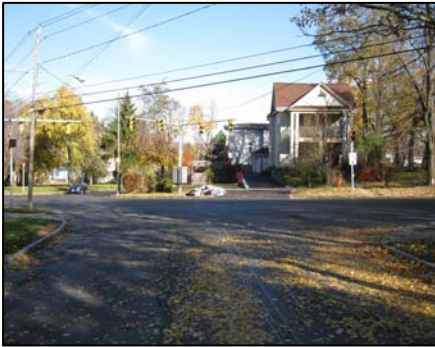
Northbound (Columbus Avenue):

A very slight downgrade that is straight as you get close to the intersection. A curve in the approach exists approximately 300 feet south of the intersection. Traffic is allowed in both directions but there are no lines delineating lanes. Both sides of the street have sidewalks and no shoulders. Odd/Even parking is allowed on this approach.

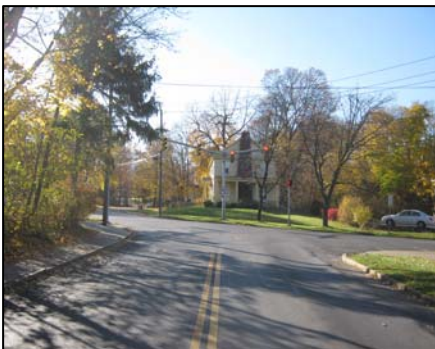
Southbound (Columbus Avenue): A straight and slight upgrade consisting of two lanes separated by a solid double yellow line. Sidewalks are present on each side of the street, with no shoulders. Parking is not allowed on this approach.

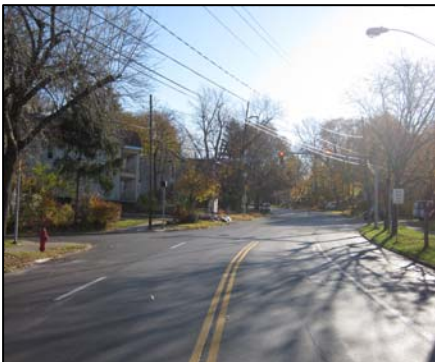
Eastbound (East Genesee Street): A straight and slight upgrade consisting of four lanes separated by a solid double yellow line. The two lanes heading east are separated by dashed white lines and eventually a solid white line as you near the intersection. The two lanes heading west are separated by dashed white lines. Sidewalks are present on each side of the street, with no shoulders. Right turns on red are not allowed and neither is parking on either side of the street.

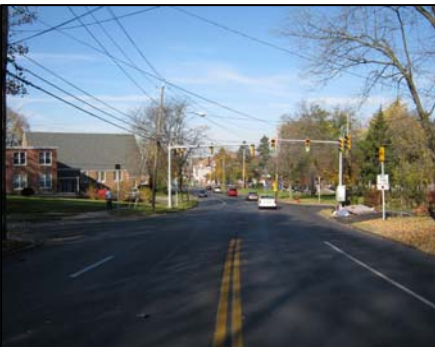
Westbound (East Genesee Street): A curved and slight downgrade consisting of four lanes separated by a solid double yellow line. The two lanes heading west are separated by dashed white lines and eventually a solid white line as you near the intersection. The two lanes heading east are separated by dashed white lines. There are no shoulders on this approach. Both sides of the street have sidewalks. Right turns on red are not allowed and neither is parking on either side of the street.

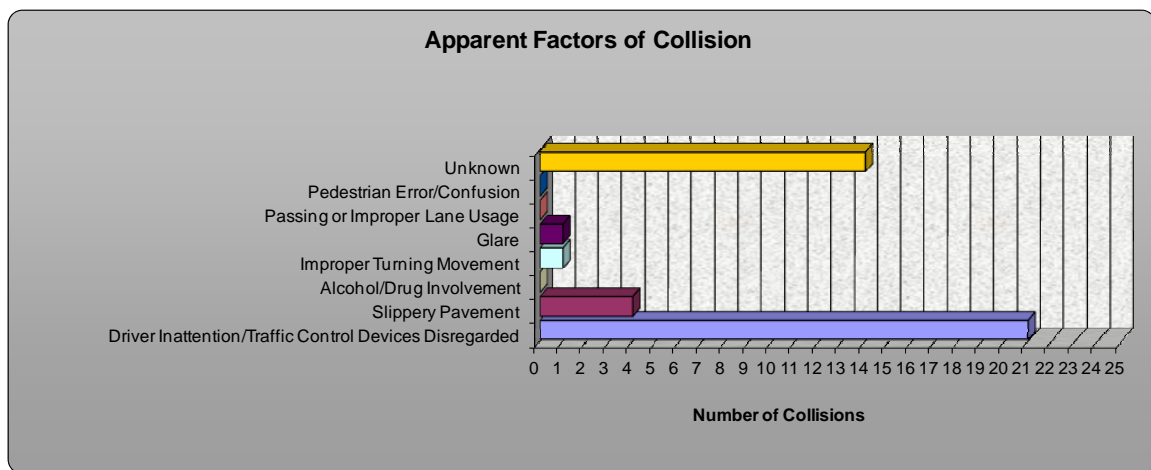
The apparent collision factors for this intersection are as follows:

Unfortunately, not all reports indicated apparent factors, as is evident by the large number of unknowns. However, from the list of apparent factors, “driver inattention/traffic control devices disregarded” shows the most collisions. “Slippery pavement” was found to be a factor in four collisions, three of which were westbound rear- end collisions. Based solely on staff’s field observation, the curved and slight downhill grade of the westbound approach could indirectly be a contributing factor to some of the collisions. As vehicles approach the intersection, the configuration of the road is such that within feet of where vehicles need to stop for the light, the street curves and goes downhill, causing drivers going westbound to have the inability to recognize vehicles stopping for a red light as they come up over the hill and around the curve.

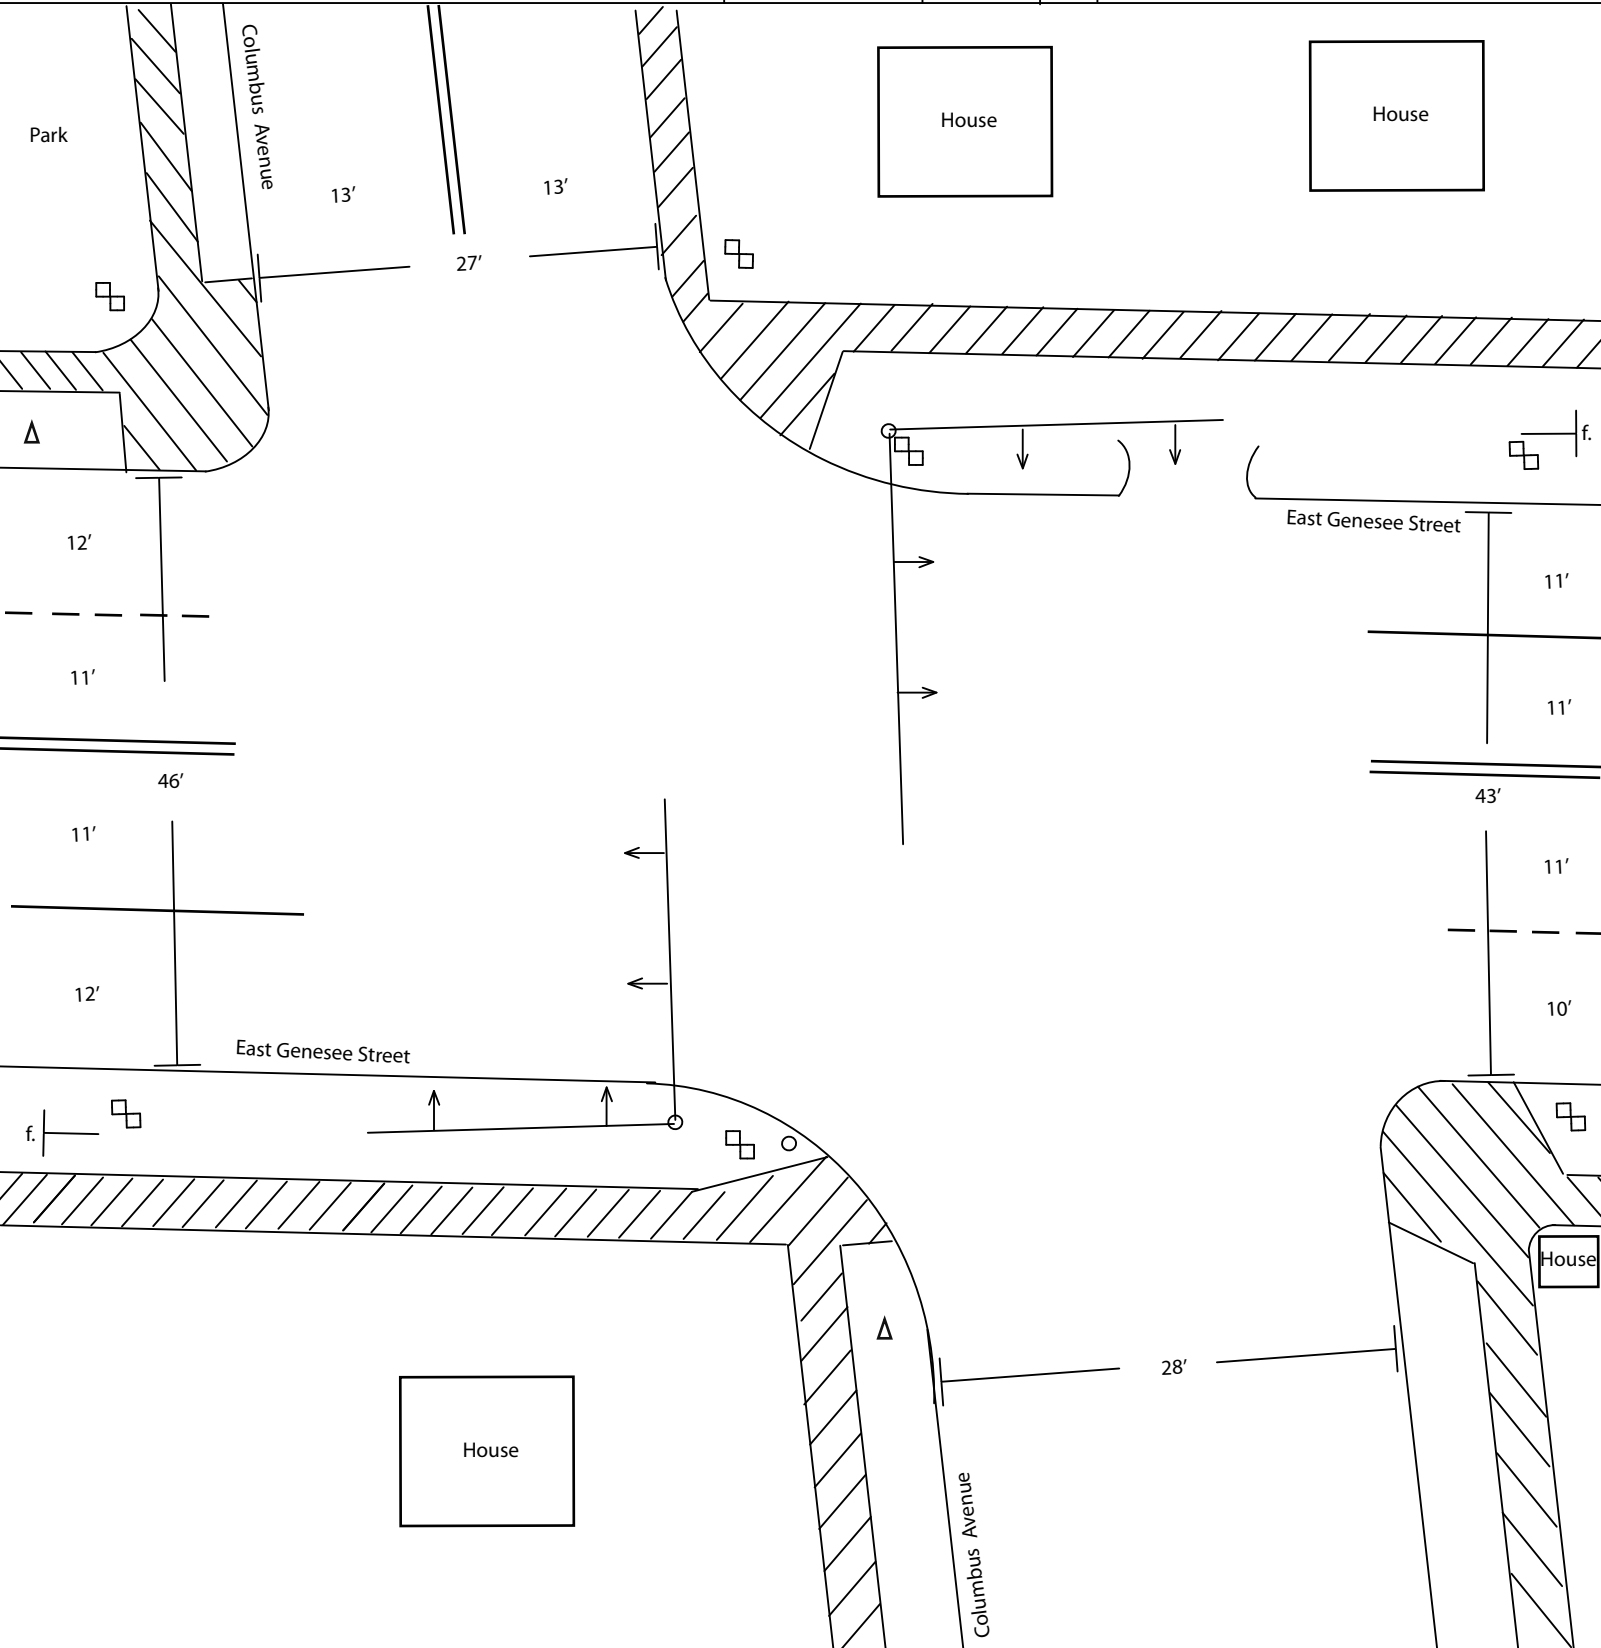
FIGURE 1-1

movement counts, intersection geometry, pavement markings, traffic signage, and signal timing and phasing plans. An intersection diagram was then completed for each intersection for a visual of the conditions at each location (see intersection diagrams corresponding to each location). Analysis of these data sets completed the problem identification phase of the project.

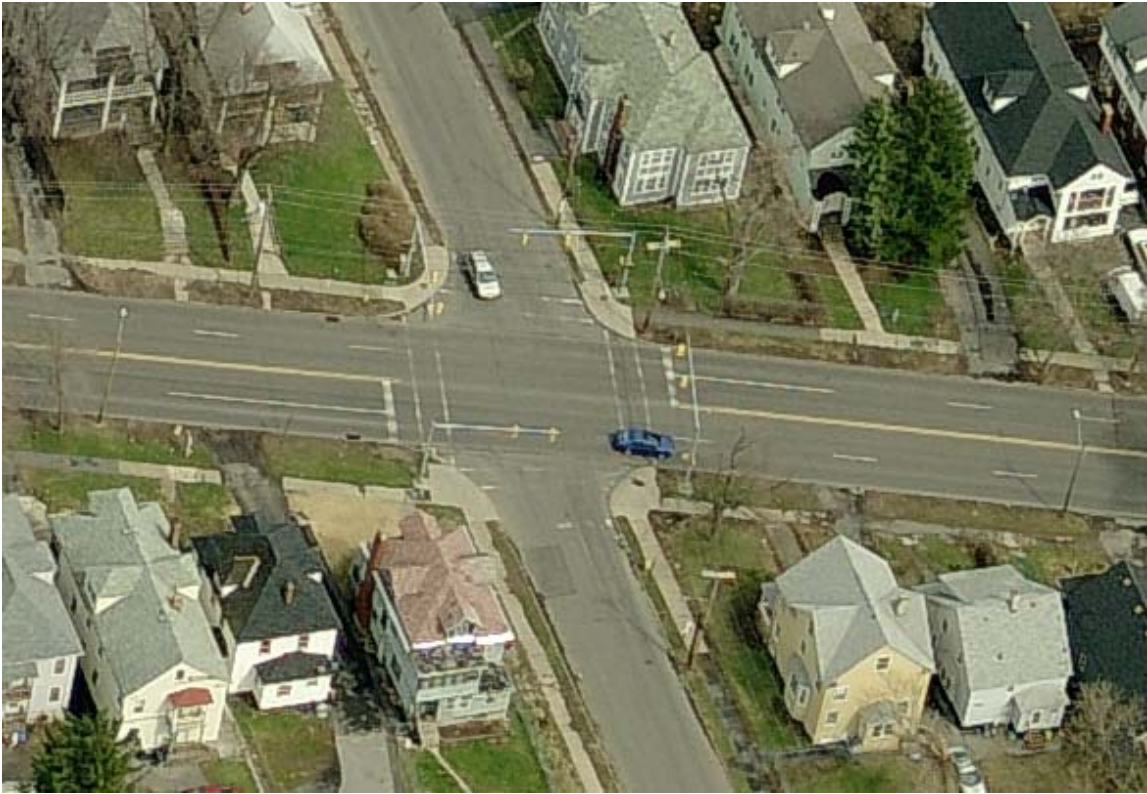
Aerial photo of East Genesee Street – Westmoreland Avenue intersection (looking north)

The immediate surrounding land use is residential. All four corners have large houses occupying them. The estimated average daily entering vehicles (ADEV) at this intersection is 12,820 vehicles per day.

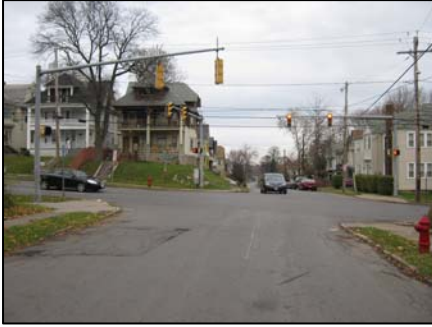
Northbound (Westmoreland Avenue): A straight and level grade allowing traffic in both directions. The lanes however are not delineated by any lines. There are sidewalks on both sides of the street, and there are no shoulders. Odd/Even parking is allowed on this approach.

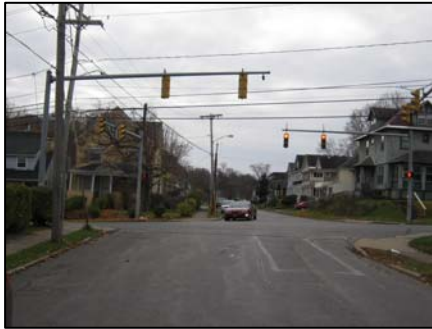
Southbound (Westmoreland Avenue): Similar to the northbound approach, this approach is a straight and level grade allowing traffic in both directions with no lines in between the lanes. There are sidewalks on both sides of the street with no shoulders. Odd/Even parking is allowed on this approach.

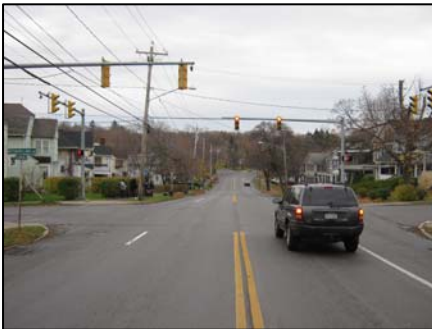
Eastbound (East Genesee Street): A straight and slight down grade consisting of four lanes separated by a solid double yellow line. The two lanes heading east as you approach the intersection are separated by a solid white line, while the two lanes heading west are separated by dashed white lines. Both sides of the street have sidewalks, and neither side has shoulders. Parking is not allowed on either side of the street

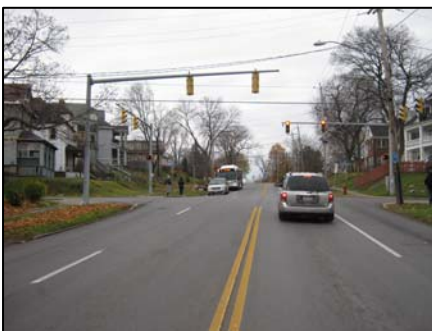
Westbound (East Genesee Street): A straight and slight upgrade consisting of four lanes separated by a solid double yellow line. As with the eastbound approach, shoulders do not exist, but sidewalks do exist on each side of the street. The two lanes heading west as you approach the intersection are separated by a solid white line, while the two lanes heading east are separated by dashed white lines. Parking is not allowed on this approach.

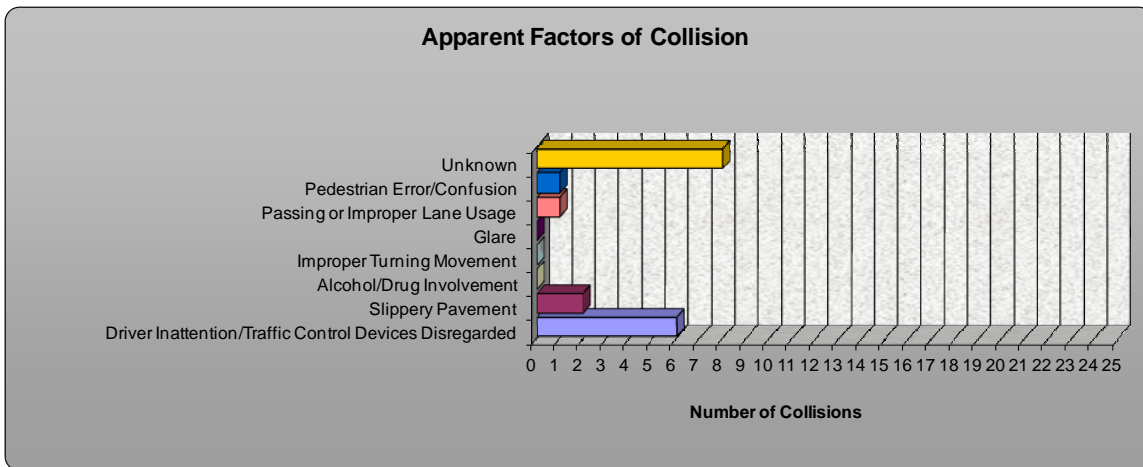
The apparent collision factors for this intersection are as follows:

Similar to the previous intersection, it unfortunately cannot be determined what were many of the factors to the collisions at this intersection. Most of the apparent factors were not recorded. For those that were recorded, the “driver inattention/traffic control devices disregarded” factor had the most collisions with 6 collisions, followed by the “slippery pavement” factor with 2. The data associated with this intersection provides no overwhelming cause of the collisions.

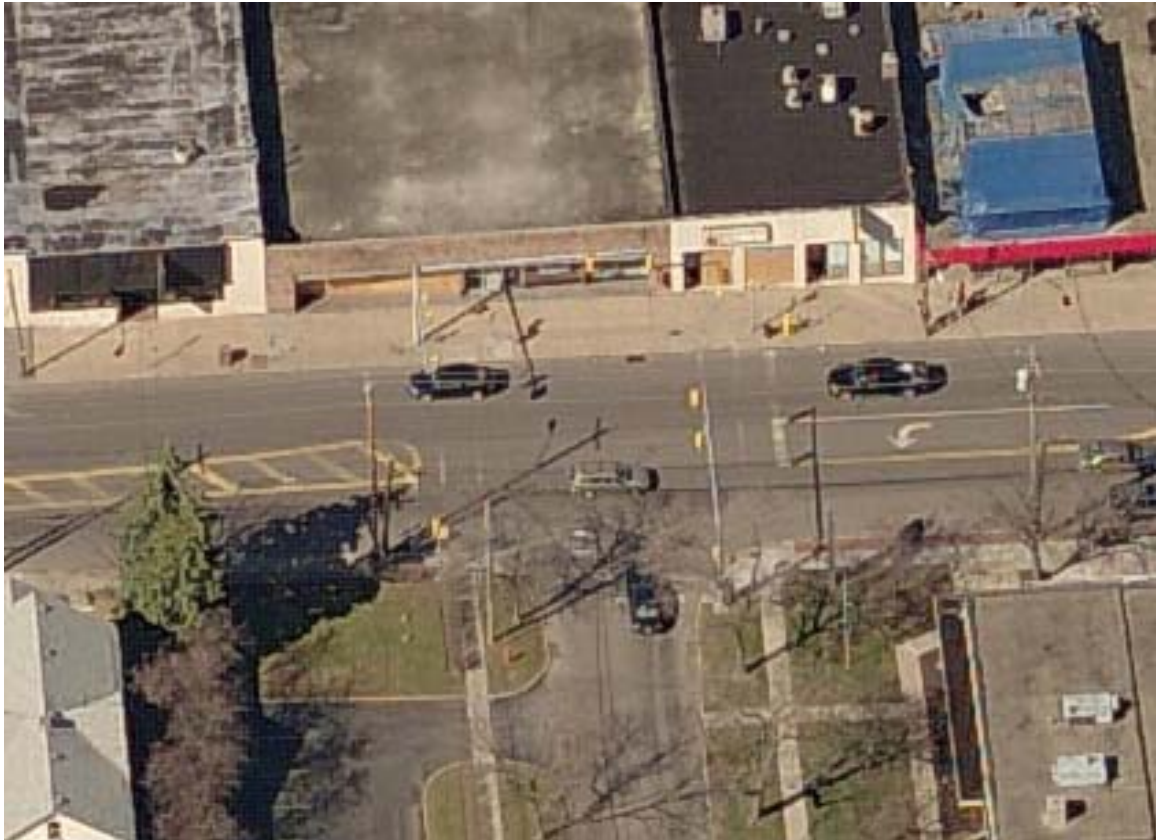
Aerial photo of James Street – Hickok Avenue intersection (looking north)

The immediate surrounding land use is mainly commercial, although behind the properties on the southern corners lies a residential neighborhood. James Street is essentially a neighborhood business district with mixed uses, while the perpendicular streets to this district are lined with residential properties. The estimated average daily entering vehicles (ADEV) at this intersection is 15,300 vehicles per day.

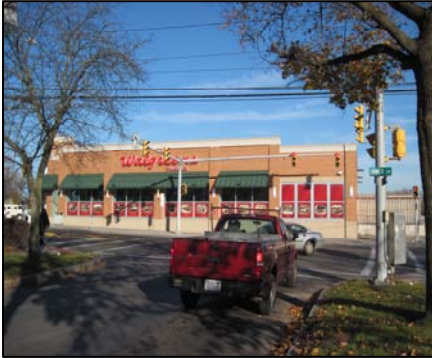
Northbound (Hickok Avenue): A straight and level grade, consisting of two lanes not separated by any lines. Traffic is allowed in both directions. Those heading north come to a T-intersection and are only allowed to go right or left. There are sidewalks on each side of the street and no shoulders. Odd/Even parking is allowed on this approach. A fading white crosswalk crosses this approach, and fading white solid stop bars cross the lane heading north.

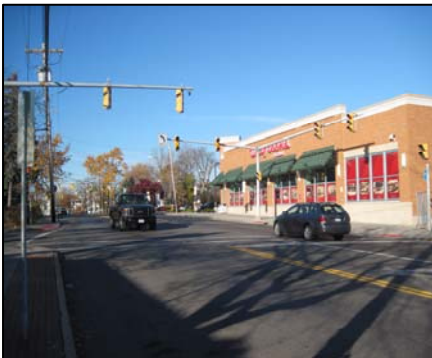
Westbound (James Street): A straight and level grade consisting of three lanes. There are two lanes heading west; one is a left-turn-only lane, and one is a through/right lane. Those two lanes are separated by a solid white line and have stop bars. The travel lane heading east is separated by the lanes traveling west by a solid double yellow line. Metered parking is available on both sides of the street. There are sidewalks on both sides of the street. Connecting those sidewalks to one another is a fading crosswalk painted white.

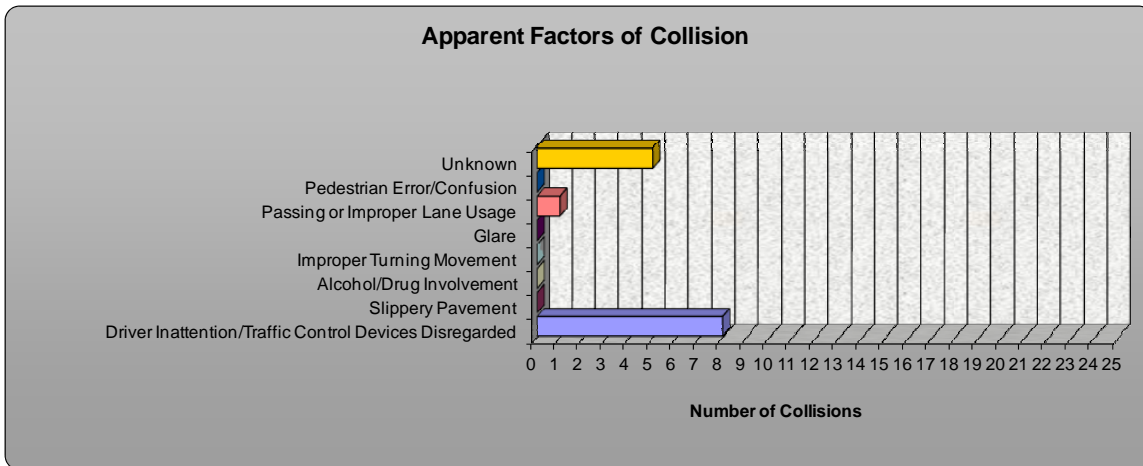
The apparent collision factors for this intersection are as follows:

Similar to previous intersections, this intersection has a large amount of the collisions with unknown apparent factors. The most common apparent factor noted in the collision reports at this intersection was the “driver inattention/ traffic control devices disregarded” factor. More specifically, many of the drivers were following too closely and were inattentive. This helps make the case that many of the collisions were simply the result of human error.

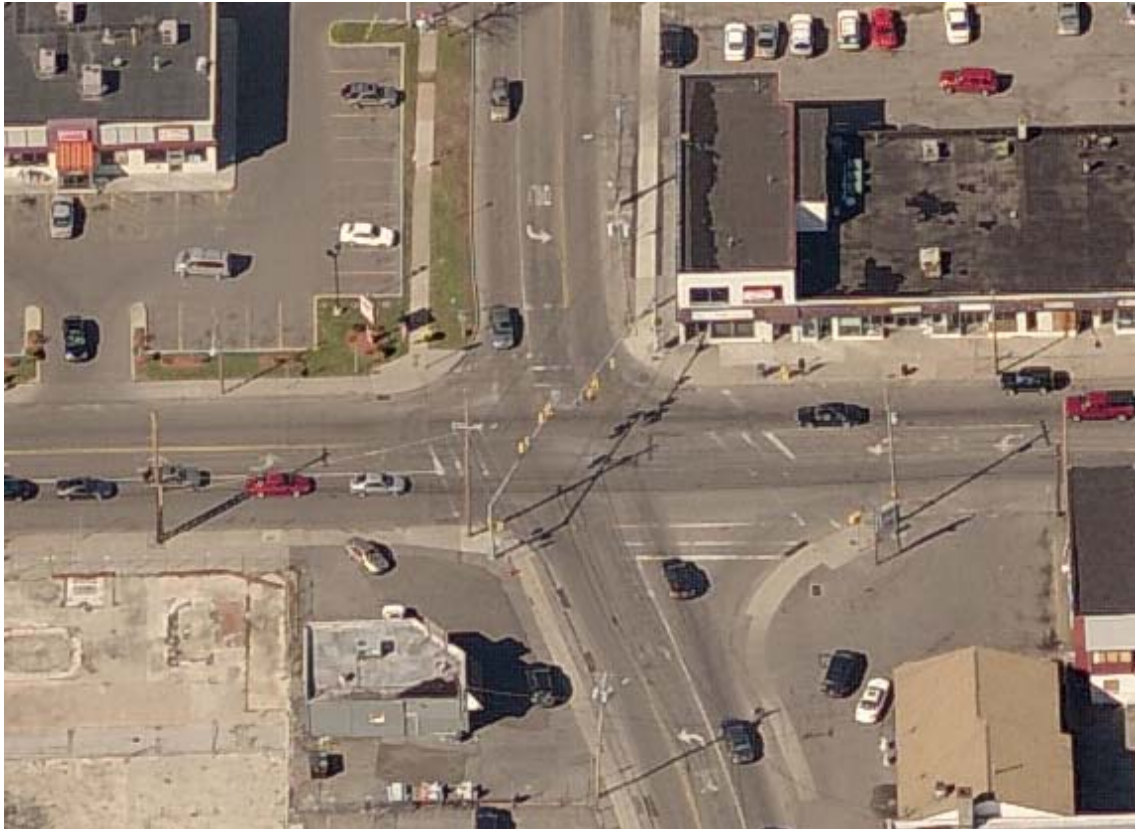
Aerial photo of James Street – S. Midler Avenue intersection (looking north)

All four corners of this intersection have commercial properties on them. As discussed in the previous intersection of James Street and Hickok Avenue, perpendicular streets to James Street consist of mainly residential properties, and Midler Avenue is no exception. However, Midler Avenue does have other land uses scattered within, but for the most part, residential properties dominate this street, while commercial properties dominate James Street. The estimated average daily entering vehicles (ADEV) at this intersection is 23,320 vehicles per day.

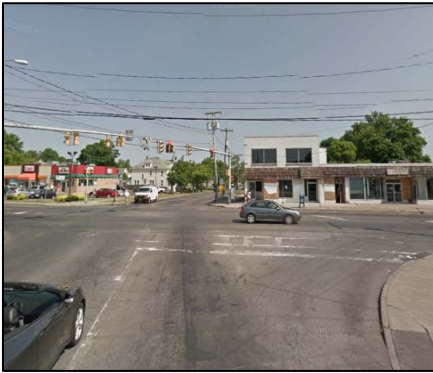
Northbound (Midler Avenue): A slightly curved and level grade consisting of three lanes. The two lanes heading north consist of one left-turn-only lane and one through/right lane which are separated from one another by a solid white line. Both of these lanes have a stop bar. The one south lane is separated from the two north lanes by a solid double yellow line. Crosswalks connect the sidewalks on each side of the street. Parking is not allowed on this approach, and neither side has shoulders.

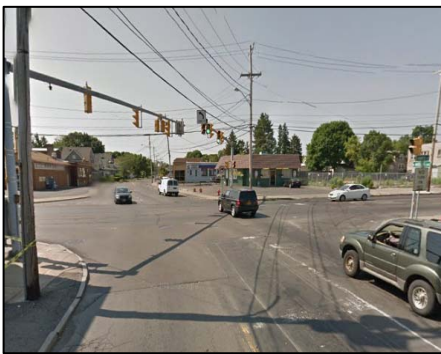
Southbound (Midler Avenue): A straight and level grade consisting of three lanes. The two lanes heading south consist of one left-turn-only lane and one through/right lane separated by a solid white line. Turning on red is not allowed and these lanes have fading white stop bars. The lane heading north is separated by those going south by a solid double yellow line. The sidewalks on this approach are connected by a fading white crosswalk. On street parking and shoulders do not exist on either side.

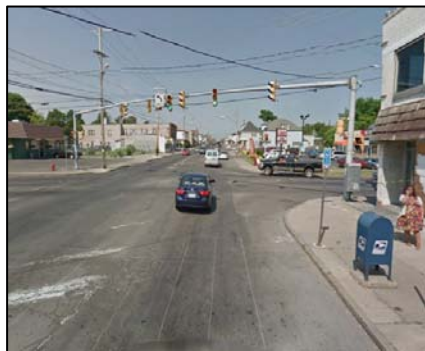
Westbound (James Street): A straight and level grade consisting of three lanes. Opposite traveling lanes are separated by a double yellow line. The two westbound lanes consist of one through/right lane and one left-turn-only lane, which are separated by a solid white line. A stop bar is present across the two westbound lanes. The crosswalk connecting the sidewalks is fading, there are no shoulders, and parking is not allowed.

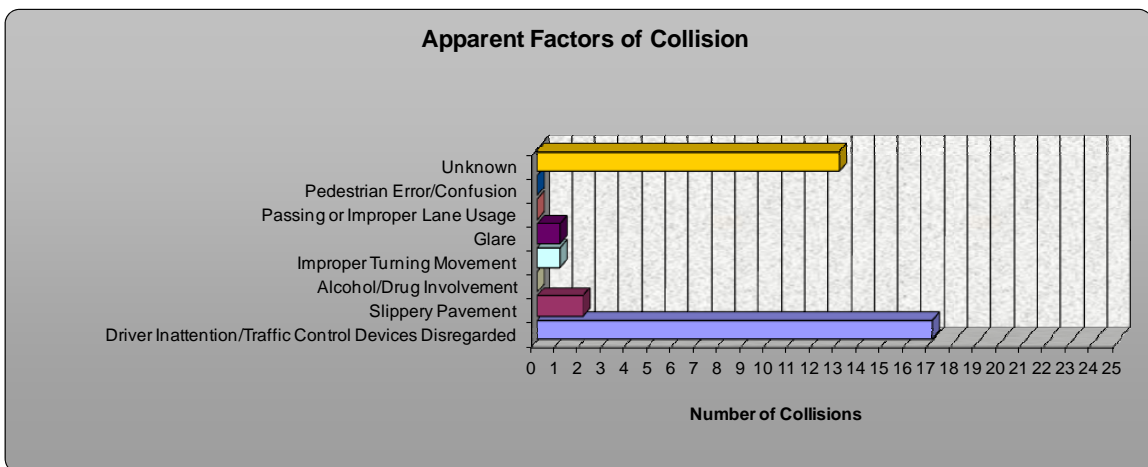
The apparent collision factors for this intersection are as follows:

Similar to previous intersections, this intersection has a large amount of the collisions with unknown apparent factors. The most common apparent factor noted in the collision reports at this intersection was the “driver inattention/ traffic control devices disregarded” factor. More specifically, many of the drivers were either following too closely, failing to yield the right of way, backing unsafely, or were simply disregarding traffic control devices and/or being inattentive. This helps make the case that many of the collisions were the result of human error.

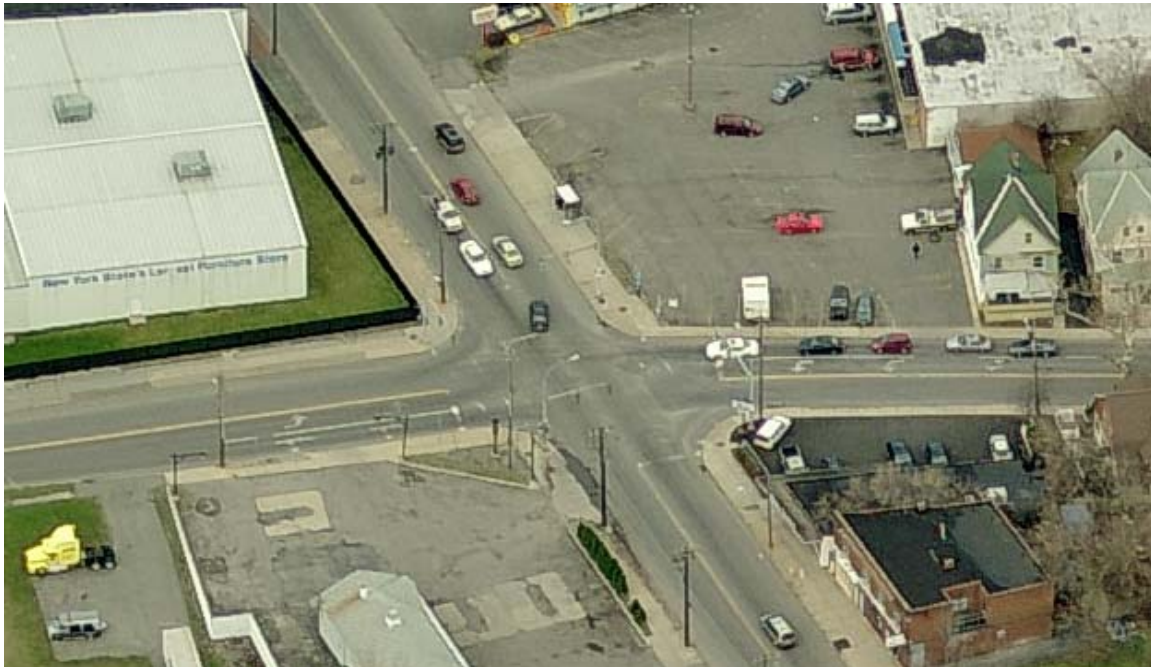
Aerial photo of S. Salina Street –Brighton Avenue (looking north)

All four corners of this intersection have commercial properties on them and/or parking lots for commercial properties. On the northwest corner is a large furniture store, on the northeast and southwest corner are other smaller stores, and on the southwest corner is a vacant gas station. The estimated average daily entering vehicles (ADEV) at this intersection is 17,940 vehicles per day.

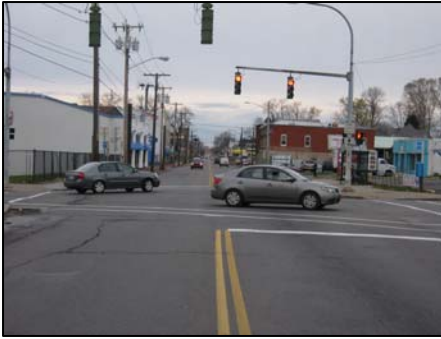
Northbound (Salina Street): A straight and level grade consisting of two lanes separated by a double yellow line. This approach has no shoulders, and parking is not allowed. A stop bar is present across the northbound lane, and a crosswalk connects the sidewalks present on both sides of the street.

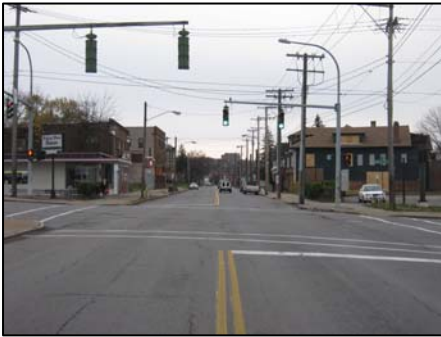
Southbound (Salina Street): A straight and level grade consisting of two lanes separated by a double yellow line. This approach has no shoulders, and parking is not allowed. A stop bar is present across the southbound lane, and a crosswalk connects the sidewalks present on both sides of the street.

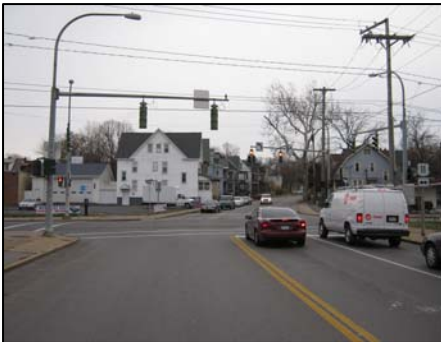
Eastbound (Brighton Avenue): A straight and level grade consisting of three lanes. The two lanes heading east consist of one left-turn-only lane and one through/right lane separated by a solid white line. Stop bar exists across these two lanes. The lane heading west is separated from the two lanes heading east by a double yellow line. There are no shoulders, and parking is not allowed in close proximity to the intersection on either side. A crosswalk connects the sidewalks on each side of the street.

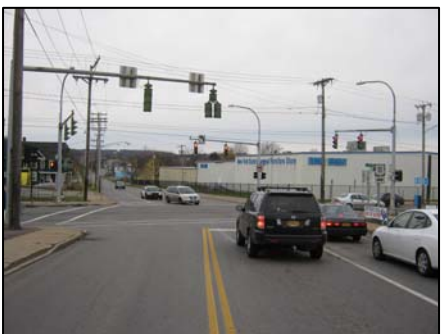
Westbound (Brighton Avenue): A slightly curved and level grade consisting of three lanes. The two lanes heading west consist of one left-turn-only lane and one through/right lane separated by a solid white line. A stop bar is present across the two lanes. The lane heading east is separated from the west lanes by a solid double yellow line. Both sides of the street have sidewalks connected by a crosswalk. Neither side allows on street parking.

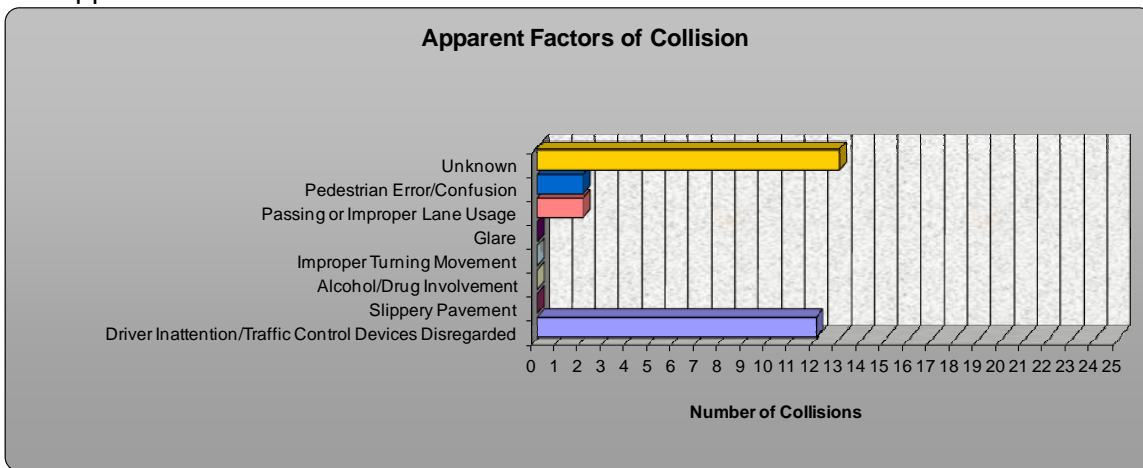
The apparent collision factors for this intersection are as follows:

Unfortunately, there was large number of “unknowns” for this intersection. However, one of the more common apparent factors noted in the collision reports at this intersection was “driver inattention/traffic control devices disregarded.” More specifically, many of the drivers were either following too closely, failing to yield the right of way, backing unsafely, or were simply disregarding traffic control devices and/or being inattentive. Beyond the “driver inattention” factor, there were two collisions caused by “pedestrian error/ confusion” and two caused by “passing or improper lane usage.” All these collision factors help make the case that many of the collisions were the result of human error.

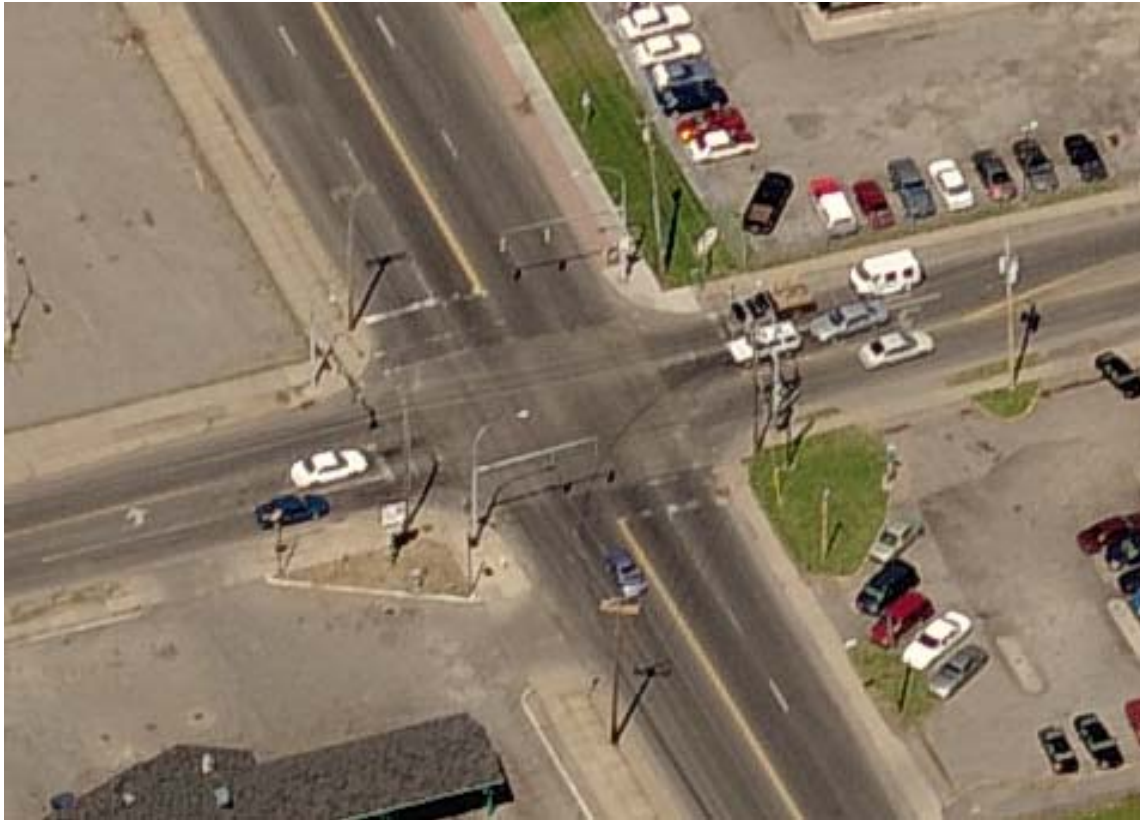
Aerial photo of S. Salina Street–Castle Street intersection (looking north)

Three corners of this intersection have commercial properties on them, a taxi garage on the northeast corner, a repair shop on the southeast corner, and a gas station on the southwest corner. The northwest corner has a large parking lot that does not appear to be in use. The estimated average daily entering vehicles (ADEV) at this intersection is 12,100 vehicles per day.

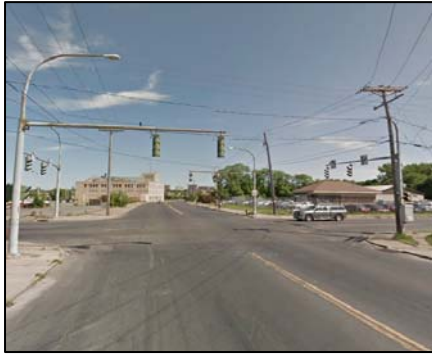
Northbound (S. Salina Street): A straight and level grade consisting of three lanes. There are two lanes going north, separated from one another by a solid white line. There is a lane going south separated from the north lanes by a double yellow line. Sidewalks exist on both sides of the street. A fading white crosswalk connects the sidewalks to one another. A stop bar is present across the two northbound lanes. There are no shoulders, and parking is not allowed on either side of the street.

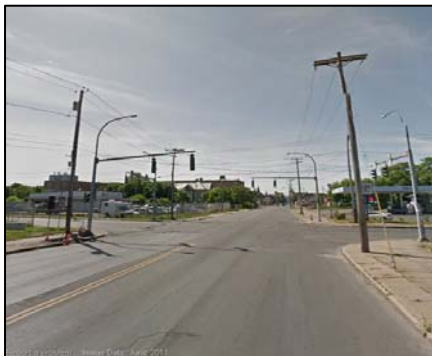
Southbound (S. Salina Street): A straight and level grade consisting of four lanes. The two lanes heading north are separated from one another by dashed white lines. The two southbound lanes are separated from one another by a solid white line as you approach the intersection. North and south lanes are separated by a solid double yellow line. Stop bars, white in color and fading, are present across the two southbound lanes. Crosswalks, fading and white, connect the sidewalks. There are no shoulders, and parking is not allowed on either side of the street.

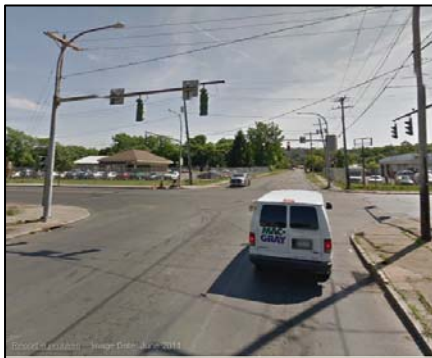
Eastbound (Castle Street): A straight and level grade consisting of three lanes. Two lanes heading east consist of one left-turn-only lane and one through/right lane separated from one another by a solid white line. These two lanes are separated from the one westbound lane by a solid double yellow line. Fading white stop bars are present across the eastbound lanes, and white fading crosswalks connect the sidewalks on both sides of the street. There are no shoulders and parking is not allowed on either side of the street.

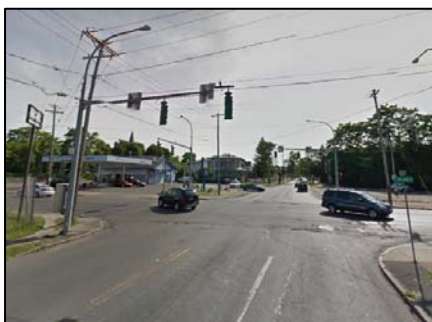
Westbound (Castle Street): A straight and level grade consisting of three lanes. Two head west, a left-turn-only lane and a through lane, separated by a solid white line. The eastbound lane is separated from the westbound lanes by a solid double yellow lane. Sidewalks on both sides, a white fading crosswalk, and stop bars across the westbound lanes all exist. There are no shoulders, and parking is not allowed.

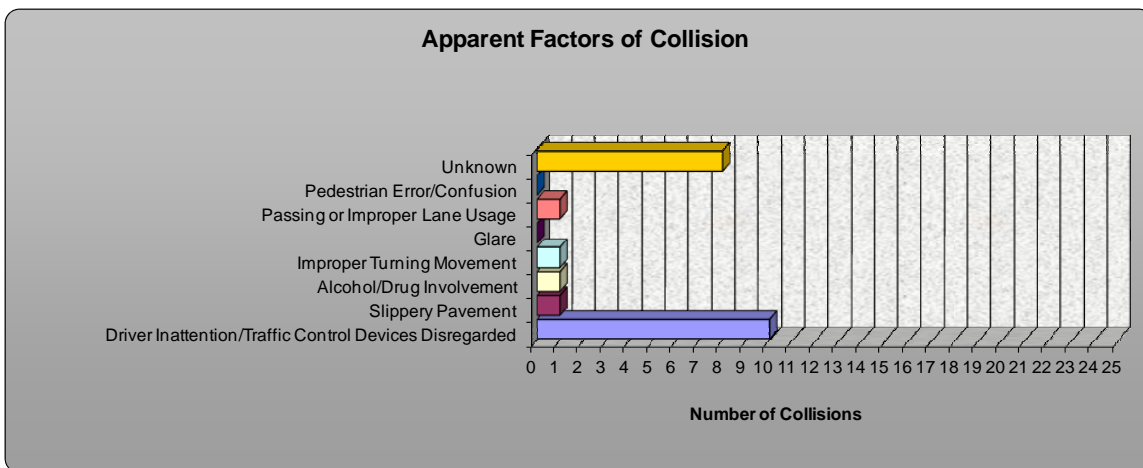
The apparent collision factors for this intersection are as follows:

The “driver inattention/traffic control devices disregarded” factor was the largest factor at this intersection. There were numerous other factors at 1 collision each. Also, unfortunately, there was once again a large number of collisions that had an unknown factor. With regard to the “driver inattention” factor, the more specific reasons under this category included driver inexperience, failure to yield the right of way, following too closely, and backing unsafely to name a few. Human error is attributable to many of these collisions.

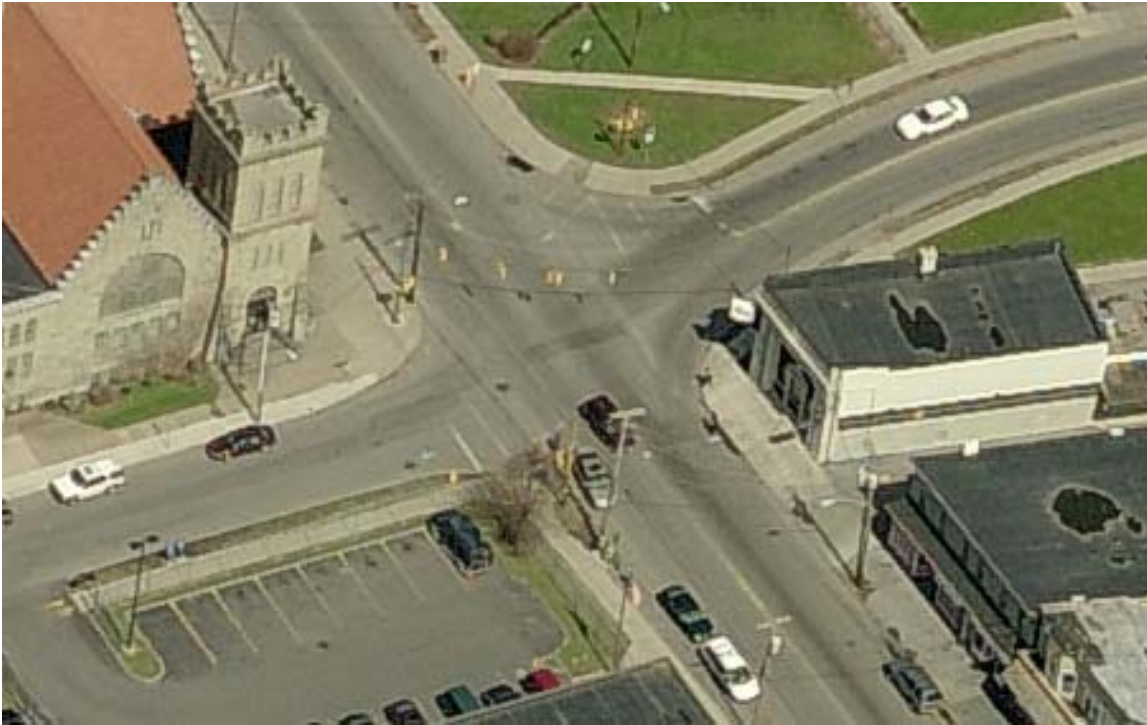
Intersection #7: S. Salina Street at Colvin Street

Aerial photo of S. Salina Street – Colvin Street intersection (looking north)

The intersection of South Salina Street (northbound and southbound) at Colvin Street (westbound) is a two-phase signalized intersection. It should be noted that Colvin Street is a one-way street going westbound after you go through the intersection. The signal phasing for this intersection is as follows:

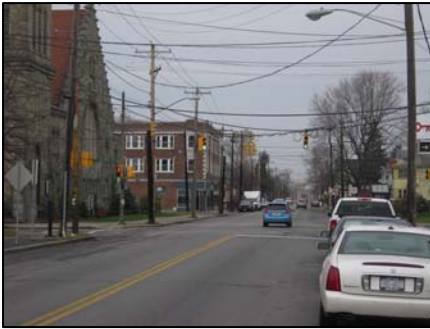
Northbound (S. Salina Street): A straight and level grade consisting of two lanes separated from one another by a solid double yellow line. There are no shoulders, and parking is allowed on both sides but with time restrictions. A stop bar sits across the northbound lane, and a crosswalk connects sidewalks on both side of the street.

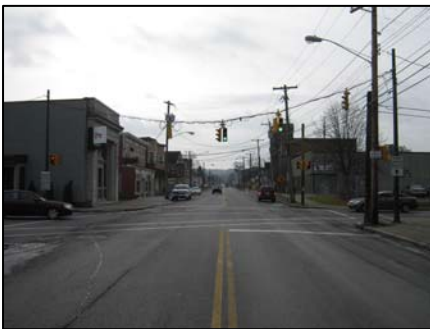
Southbound (S. Salina Street): A straight and level grade consisting of two lanes separated by a solid double yellow line. There are no shoulders, and parking is not allowed on either side of the street. A stop bar sits across the southbound lane, and a crosswalk connects sidewalks on both side of the street.

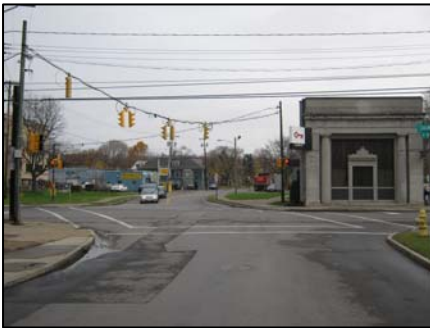
Eastbound (Colvin Street): A straight and level grade consisting of one lane. Traffic is only allowed to travel west. There is a white crosswalk connecting the sidewalks that exist on both sides of the street. There are no other lines and no defined shoulders. Odd/Even parking is allowed.

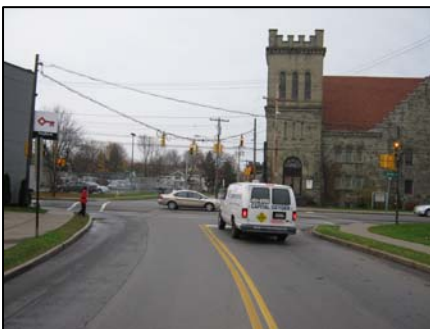
Westbound (Colvin Street): A slightly curved and level grade consisting of two lanes separated by a solid double yellow line. There is a white stop bar across the westbound lane. White painted crosswalks join the sidewalks on both sides of the street. There are no shoulders, and parking is not allowed on either side.

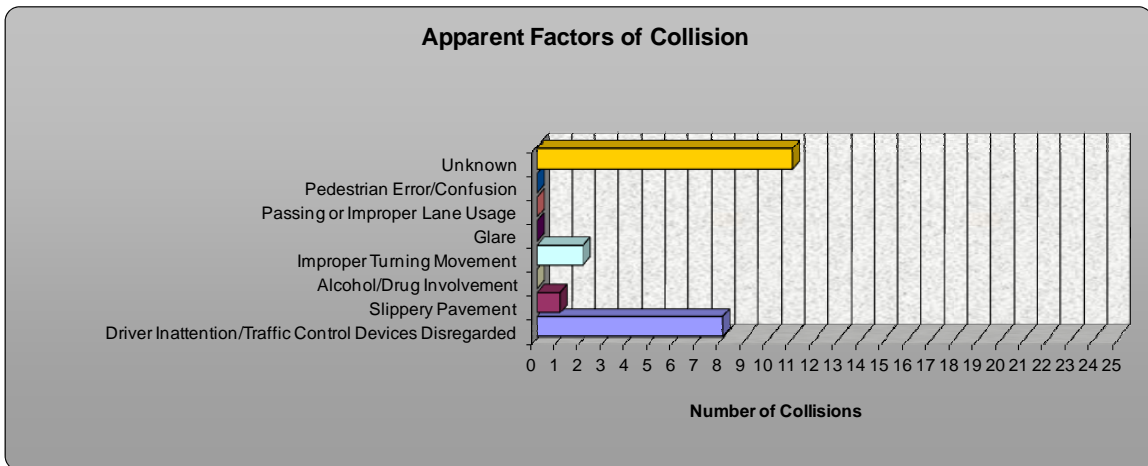
The apparent collision factors for this intersection are as follows:

The list of apparent factors provides a slightly clearer picture to the cause of the collisions at this intersection. It indicates that most of the collisions were due to human error involving the two factor categories of “driver inattention/traffic control devices disregarded” and “improper turning movement.”

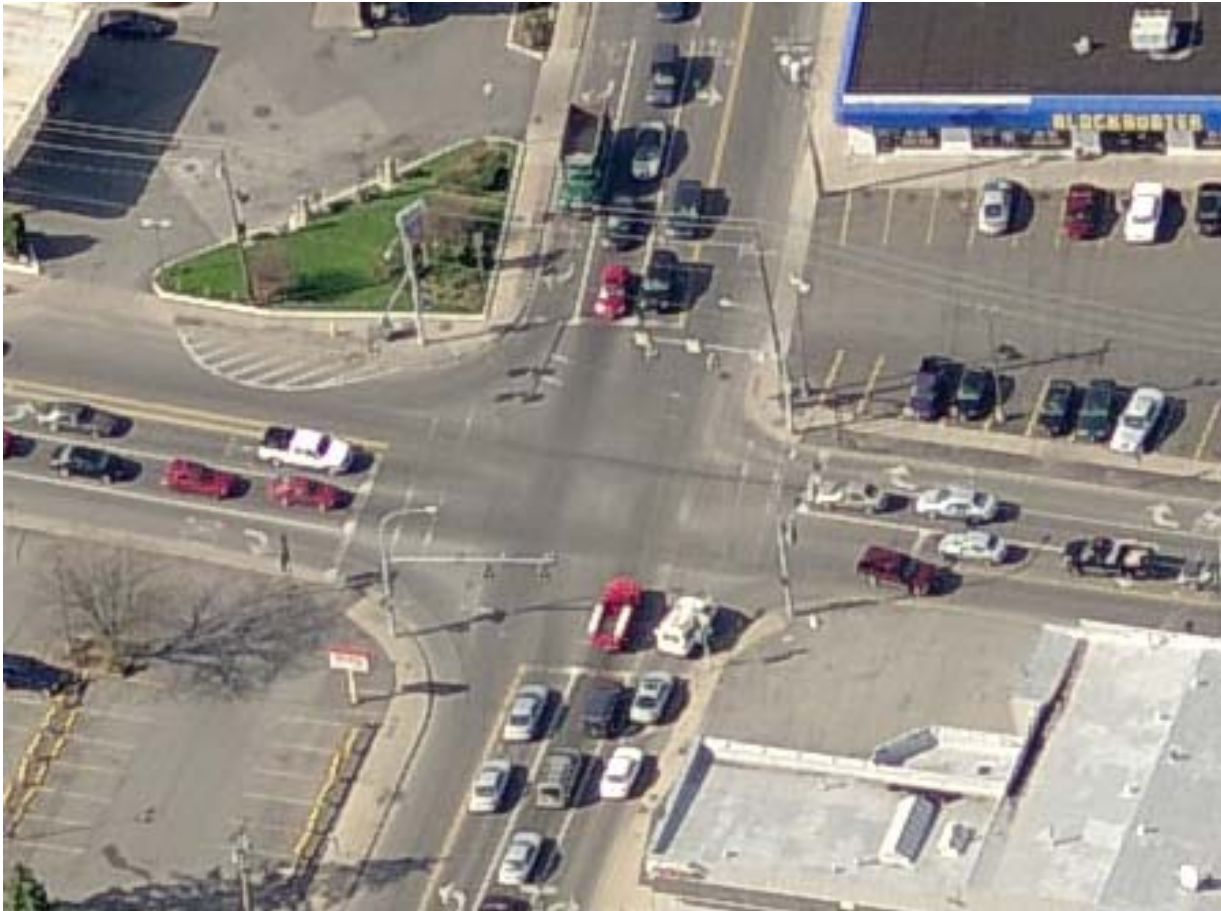
Intersection #8: S. Salina Street at Seneca Turnpike

Aerial photo of S. Salina Street – Seneca Turnpike (looking north)
