Safety Improvement Analysis

City of Syracuse

Syracuse Metropolitan Transportation Council

February 2013

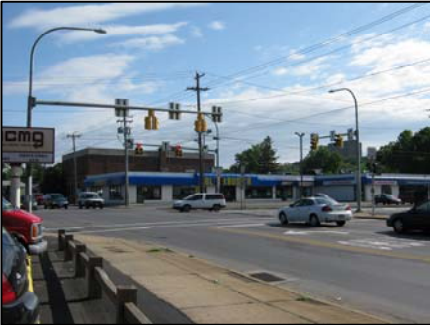
Northbound (S. Salina Street): A straight and level grade consisting of four lanes, three heading north and one heading south. Lanes going in opposite direction are separated by a double yellow line. Northbound lanes consist of a left-turn-only lane, a through lane, and a right-turn-only lane, and are separated from one another by a solid white line. There are no shoulders, and parking is not allowed. Faded white crosswalks connect the sidewalks on either side of the street, and a faded stop bar is present across the northbound lanes.

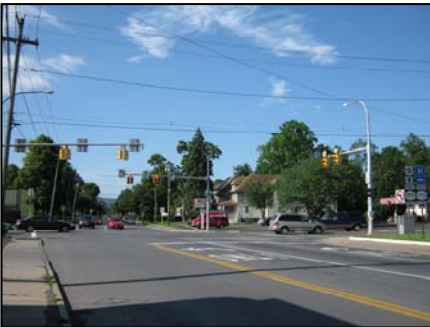
Southbound (S. Salina Street): A straight and level grade consisting of four lanes, three heading south, and one heading north. The northbound and southbound lanes are separated by a double yellow line. The southbound lanes consist of a left-turn-only lane, a through lane, and a right-turn-only lane that are separated from one another by a solid white line. There are no shoulders, and parking is not allowed. A fading white crosswalk connects the sidewalks on either side of the street, and a faded stop bar is present across the lanes going south.

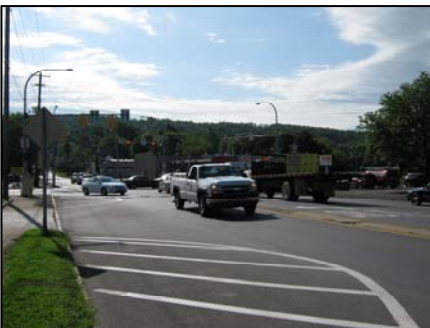
Eastbound (Seneca Turnpike): A straight and level grade consisting of four lanes, three heading east, and one heading west. Opposite direction lanes are separated by a solid double yellow line. The eastbound lanes consist of a left-turn-only lane, a through lane, and a right-turn-only lane, and are separated from one another by a solid white line. There is a shoulder on the westbound lane, but parking is not allowed on either side. A fading white crosswalk and a stop bar across the eastbound lanes are present. A sidewalk exists only on the north side.

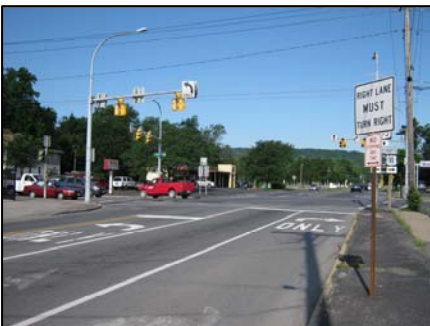
Westbound (Seneca Turnpike): A straight and level grade consisting of four lanes, three heading west, and one heading east. Opposite direction lanes are separated by a solid double yellow line. The westbound lanes consist of a left-turn-only lane, a through lane, and a right-turn-only lane, separated by white solid line. They all have stop bars. There are no shoulders, and parking is not allowed. A fading white crosswalk exists, while only a sidewalk exist on the northside.

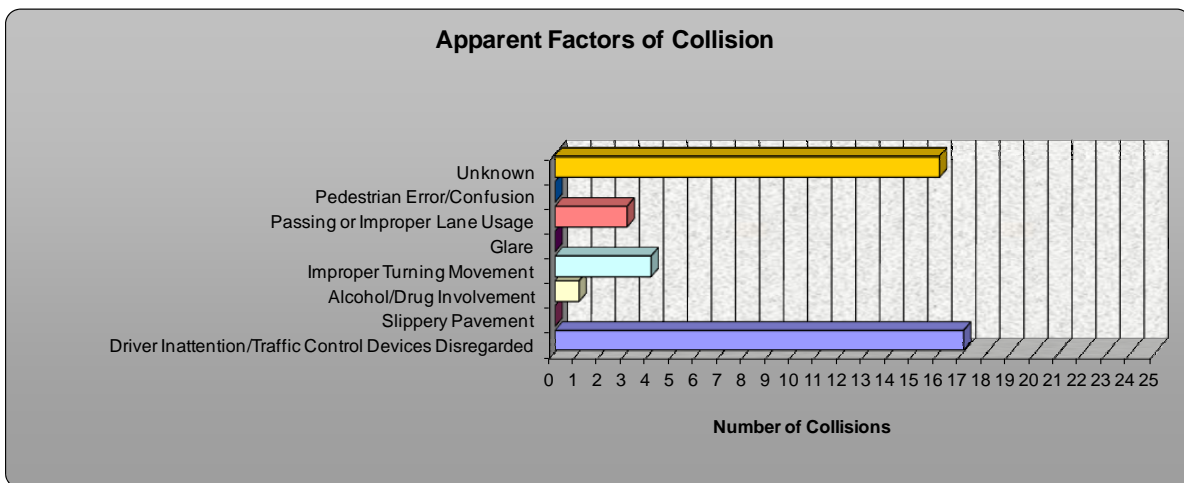
The apparent collision factors for this intersection are as follows:

Based upon the data presented and the apparent collision factors shown above, it could be said that many of the collisions at this intersection are due to human error because of multiple reasons, the biggest being driver inattention, and more specifically, following too closely or failing to yield the right of way.

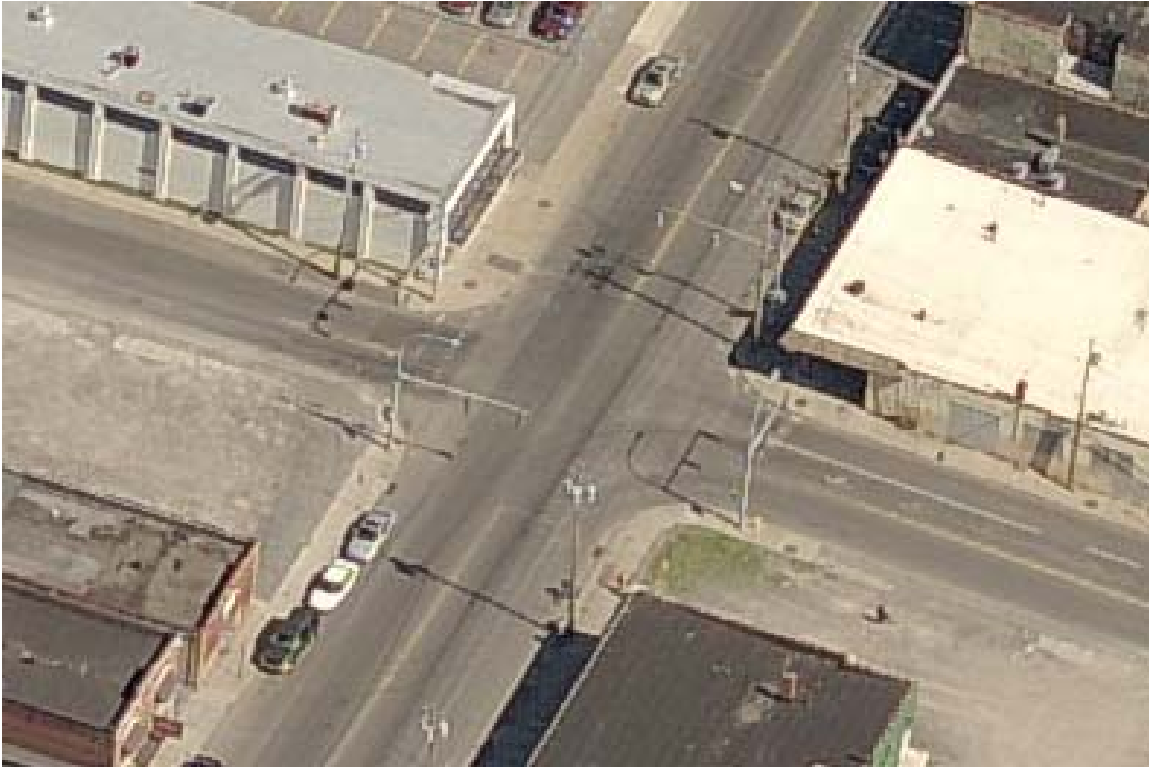
Intersection #9: South Avenue at Brighton Avenue

Aerial photo of South Avenue – Brighton Avenue intersection (looking north)

It should be noted that during field observations it was found that there was not an “all red” phase.

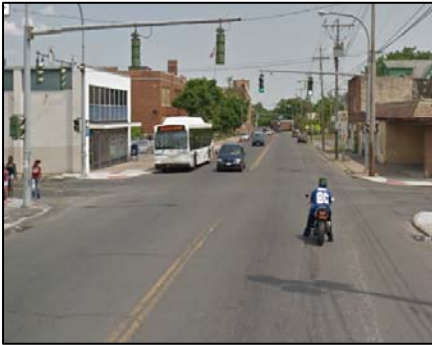
Northbound (South Avenue): A straight and level grade consisting of two lanes separated by a solid double yellow line. There are no shoulders, and the crosswalk is faded to non-existent, as is the case with stop bar across the northbound lane. Parking is allowed on both sides of the street with limitation.

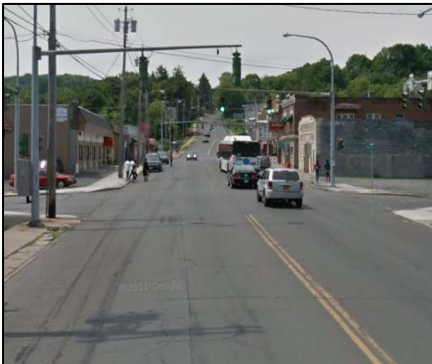
Southbound (South Avenue): A straight and level grade consisting of two lanes separated by a solid double yellow line. There are no shoulders and the crosswalk is very faded to non-existent, as is the case with stop bar across the southbound lane. Parking is not allowed on the west side in close proximity to the intersection, while the eastside of the street allows parking but is not clear as to the limitations.

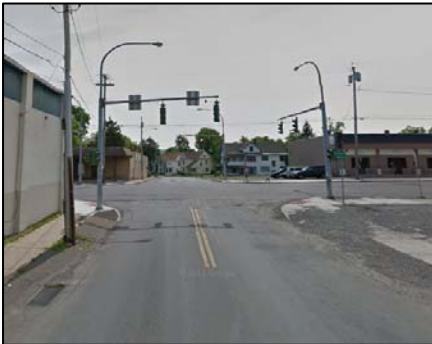
Eastbound (Brighton Avenue): A straight and level grade consisting of two lanes separated by a solid double yellow line. There are no shoulders and the crosswalk and stop bar on the eastbound lanes are very faded to non-existent. Parking is not allowed on either side of the street. There are sidewalks on both sides.

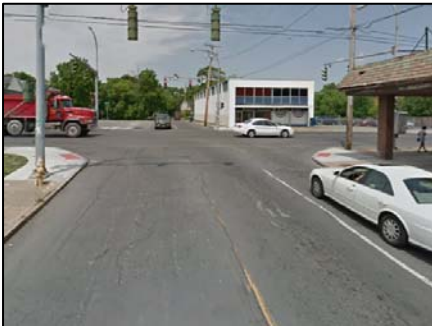
Westbound (Brighton Avenue): A straight and level grade consisting of three lanes. A left-turn-only lane and a through/right lane going westbound are separated from one another by a solid white line. The lanes going in different direction are separated by a solid double yellow line. Approximately 200' from the intersection the road begins to curve. There are no shoulders and parking is not allowed on either side of the street. Any stop bars or crosswalk are faded to non-existent. Sidewalks are present on both sides of the street.

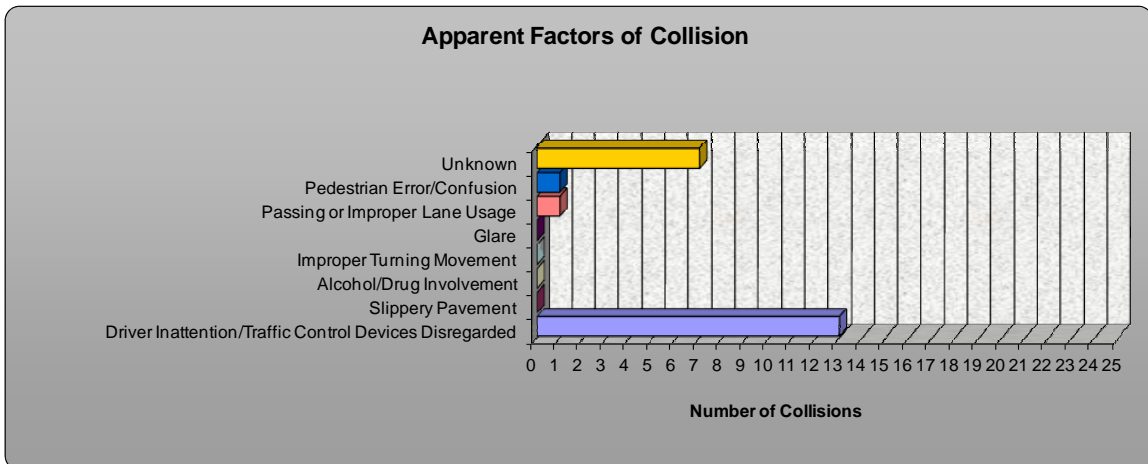
The apparent collision factors for this intersection are as follows:

The list of apparent factors provides a slightly clearer picture to the cause of the collisions at this intersection. It indicates that most of the collisions were due to human error involving the two factor categories of “driver inattention/traffic control devices disregarded” and “passing or improper lane usage.” Some the more specific reasons under these categories were drivers following too closely, traveling at an unsafe speed, or failing to yield the right of way.

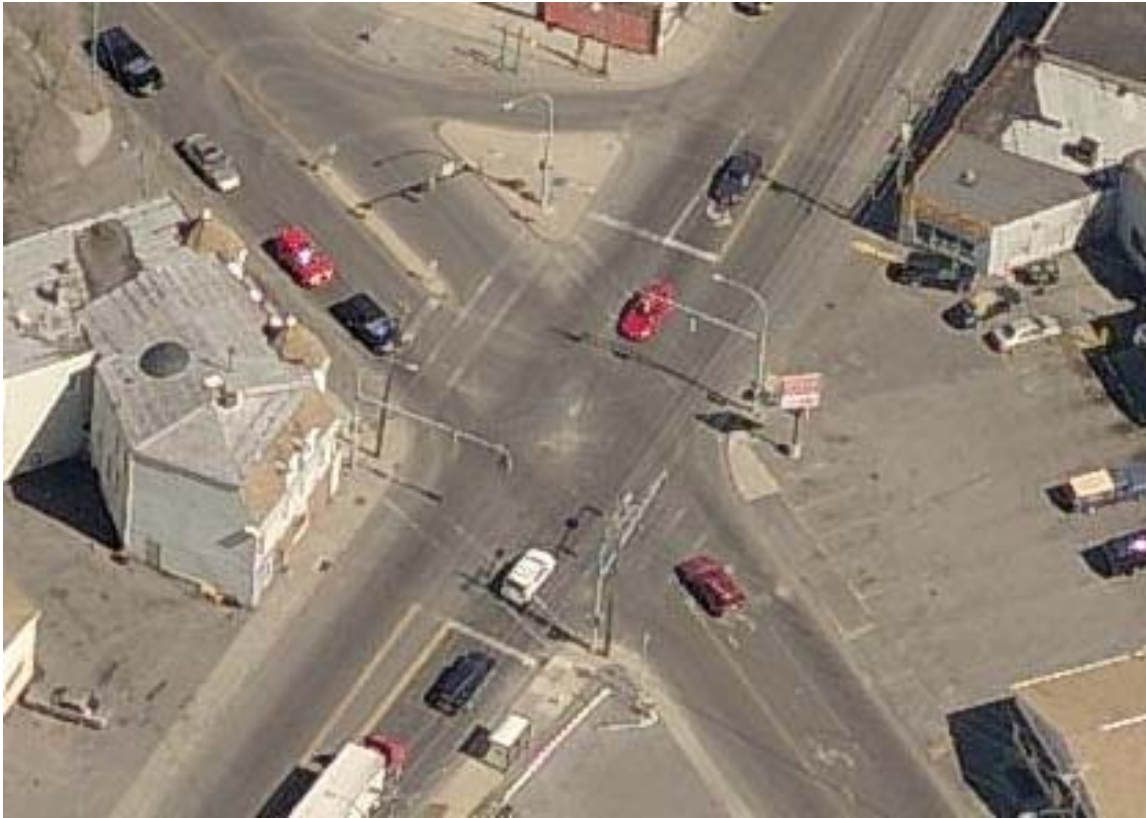
Intersection #10: South Avenue at Glenwood Avenue

Aerial photo of South Avenue – Glenwood Avenue intersection (looking north)

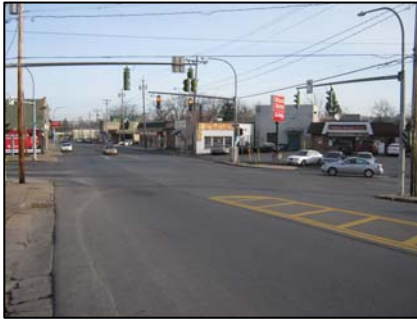
Northbound (South Avenue): A straight and downhill grade consisting of two lanes, separated by two sets of solid double yellow lines forming a yellow striped median approximately 7' in width. There are no shoulders and no parking is allowed on either side of the street. A fading to non-existent stop bar exists across the northbound lane.

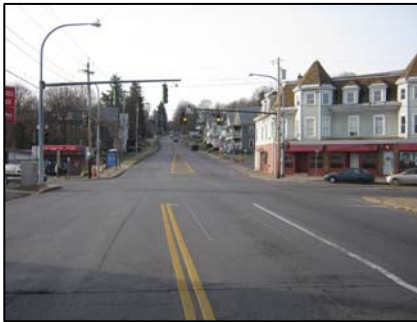
Southbound (South Avenue): A straight and level grade consisting of three lanes. The two lanes heading south consist of one left-turn-only lane and one through/right-turn lane with vehicles being forced to take a right due to a concrete median directing them in that direction. These two lanes are separated by a solid white line. The lanes heading in opposite direction are separated by a solid double yellow line. There are no shoulders, and limited parking is allowed on both sides of the street. A very faded to non-existent crosswalk is present, as is a very faded stop bar across the southbound lanes.

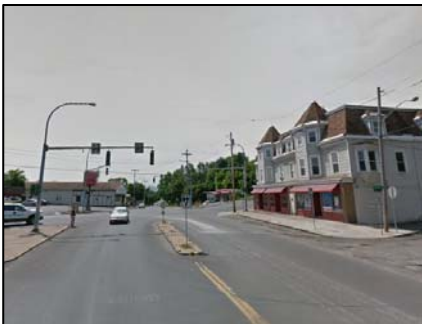
Eastbound (Glenwood Avenue): A straight and level grade consisting of three lanes. The two lanes heading east consist of a left-turn-only lane and one through/right-turn-only lane. They are separated by a solid white line. The lane heading westbound is separated from the eastbound lanes by a solid double yellow line and a concrete median of approximately 4' in width. The road begins to curve about 200' before reaching the intersection. There are no shoulders and no parking going west. Going east, parking is limited. The crosswalk and stop bar across the eastbound lanes are very faded to non-existent.

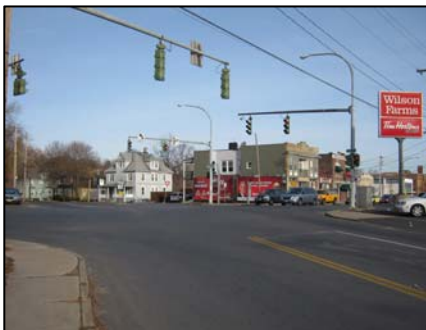
Westbound (Valley Drive): A straight and level grade consisting of three lanes. Two lanes heading west consist of one left-turn-only lane and one through/right-turn only lane. They are separated from one another by a solid white line. The lane heading east is separated from the westbound lanes by a solid double yellow line. There are no shoulders, and parking is not allowed. Sidewalks are present on both sides of the street. Stop bars across the westbound lanes and the crosswalk across the approach are very faded to non-existent.

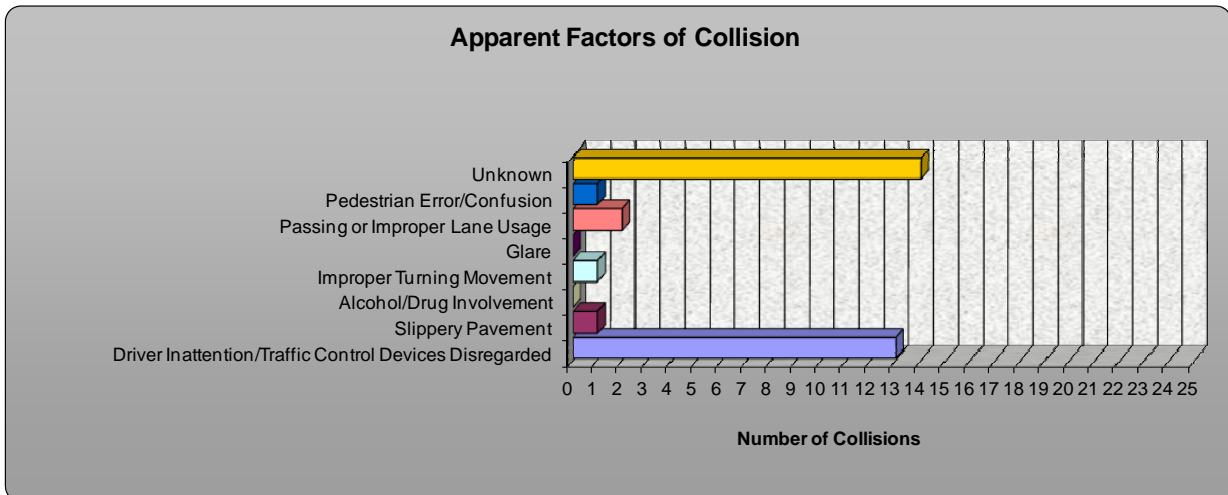
The apparent collision factors for this intersection are as follows:

The apparent factors of collision indicate that the majority of the collisions at this intersection were due to human error, particularly “driver inattention/traffic control devices disregarded”. Drivers at this intersection failed numerous times to yield the right of way and a couple backed up unsafely. It should be re-stated that three of the total collisions at this intersection was with a pedestrian. Again, unfortunately a large number of collisions do not have an apparent factor due to lack of information recorded at the scene.
