City of Syracuse Sidewalk Study Technical Memorandum

OCTOBER 2024

TECHNICAL MEMORANDUM

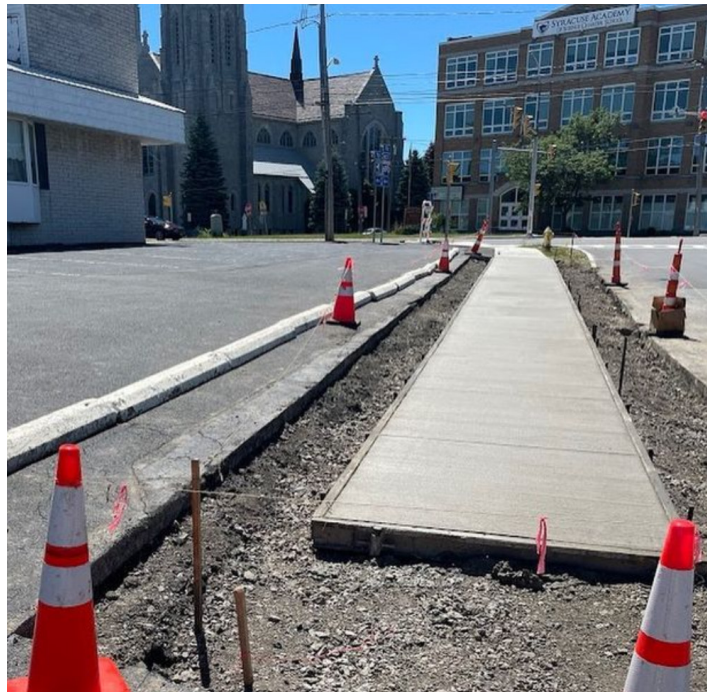
Figure 1
Street Frontage Miles Inventoried by Year

Approximately 200 miles of sidewalk were inventoried each year, with the exception of the first and last years of the program. In 2020, data collectors also inventoried parking signs in selected neighborhoods as a part of a separate SMTC study. In 2024, four SMTC interns were used, which sped up the data collection process and allowed the agency to complete the inventory before the summer ended. Figure 1 below shows the number of miles rated each year in bars, and the total cumulative rated miles in an orange line.

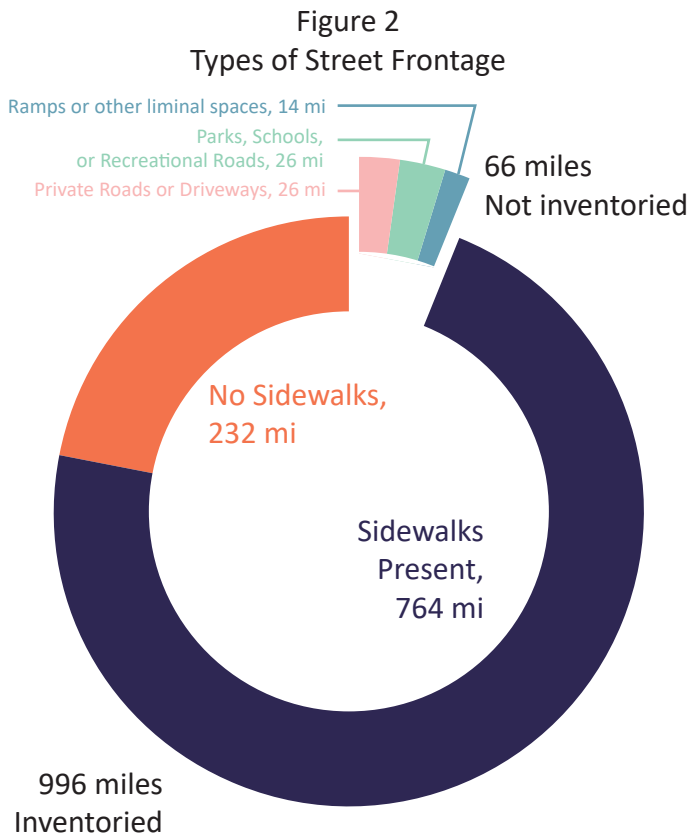
This project is more accurately an inventory of street frontage, rather than just sidewalks. SMTC staff estimate that there are 1,062 miles of street frontage in the city. This number does not include limited access highways, but does include the frontage on roads not used by the traveling public, such as park roads and roads on school properties.

SMTC staff reviewed the overall street frontage and focused only on roads used for travel. This reduced the miles of street frontage to 996 miles, which is what the inventory consists of.

Of those inventoried miles, 232 miles did not have sidewalks. These parcels have no additional data tied them. Figure 2 below shows the different types of street frontage in the city and explains which types were included in the inventory.

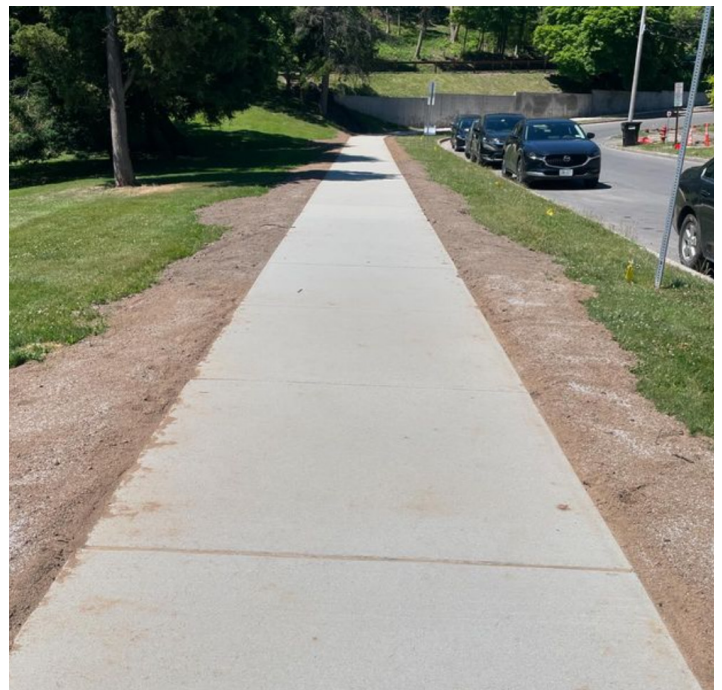
Of the sidewalks that currently exist in the city, the majority have conditions that are considered Accessible (4) or Fully Accessible to Current Standards (5). Parcels currently without sidewalks could be targeted for installation if conditions allow. Figure 4 below illustrates condition ratings in the sidewalk database.

The condition rating will allow the City to proactively plan sidewalk maintenance as a part of a larger prioritization model. The City already utilizes a prioritization model to pave roads, and a similar model could be created for sidewalks.
